Blade Lock Ring of 4th Stage Compressor Rotor: Failure Investigation

Aginaparru Sambasiva Rao and Ashok Kumar Singh

Present work describes the failure investigation of blade lock ring of 4th stage compressor rotor. The lock ring is fabricated from martensitic stainless steel. The microstructure of failed lock ring is tempered martensite. It shows non-metallic inclusions with three distinct shapes namely, elongated (MnS), globular (Al₂O₃) and complex shaped (oxy-sulphide). The corrosion pits and corrosion debris are observed in un-etched microstructure and fracture surface, respectively. The tree like branching cracks has observed at several places near surface. These cracks have initiated from the corrosion pits and then propagated inside the material. The interface of inclusions and matrix has also acted as crack initiator. The lock ring has initially suffered pitting corrosion in service and then cracks have propagated inside the material by stress corrosion cracking.

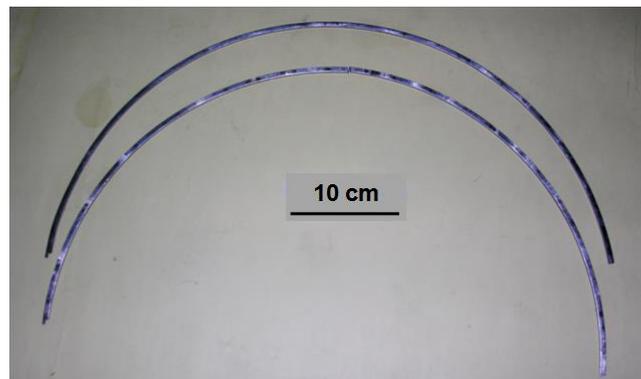
Photograph of broken lock ring in as-received condition is shown in Fig. 1. The ring is in the form of flat surface all around the circumference. The width and the thickness of the lock ring are 5.5 and 2.5 mm, respectively. It clearly shows that the lock ring has broken into two pieces. These rings are smooth and shiny surface finish on both plane surfaces. It also exhibits several micro-cracks along one side of plane surface of the both parts of lock rings and are extended from one end to other end (Fig. 2a). These cracks are confirmed by dye penetrate (DP) test and also with stereo microscopic examinations (Figs. 2a and 3). Close inspection of the fracture surface in stereo microscope of failed lock ring displays two distinct features with dark and bright contrast (Fig. 2b). The major part (~75%) of the fracture surface exhibits dull and dark contrast while the remaining part (~25%) is bright and shiny.

Figure.1: Broken parts of lock ring in as-received condition.

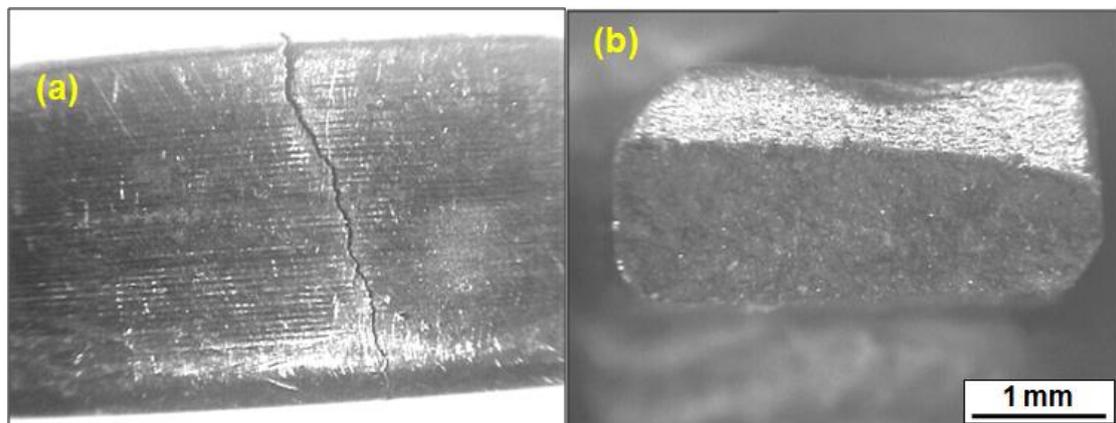
Figure. 2: Stereo micrographs of failed lock ring: (a) irregular crack across the width on one plane surface and (b) dark and bright fracture surface obtained from broken lock ring.

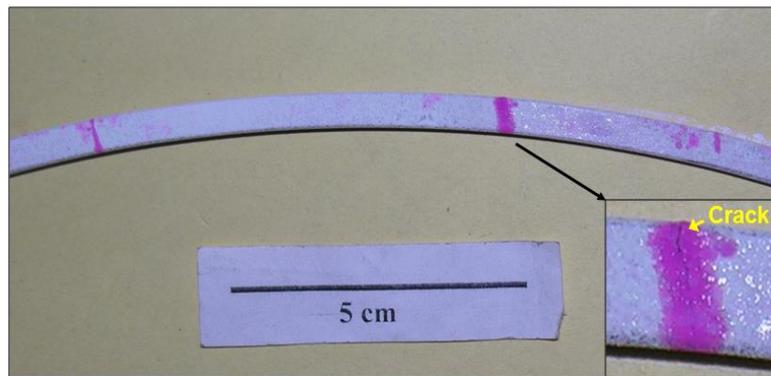
Figure.3: Photograph of post dye penetrant test showing several cracks across the width on one plane surface of failed lock ring (magnified image of crack region is shown as inset).

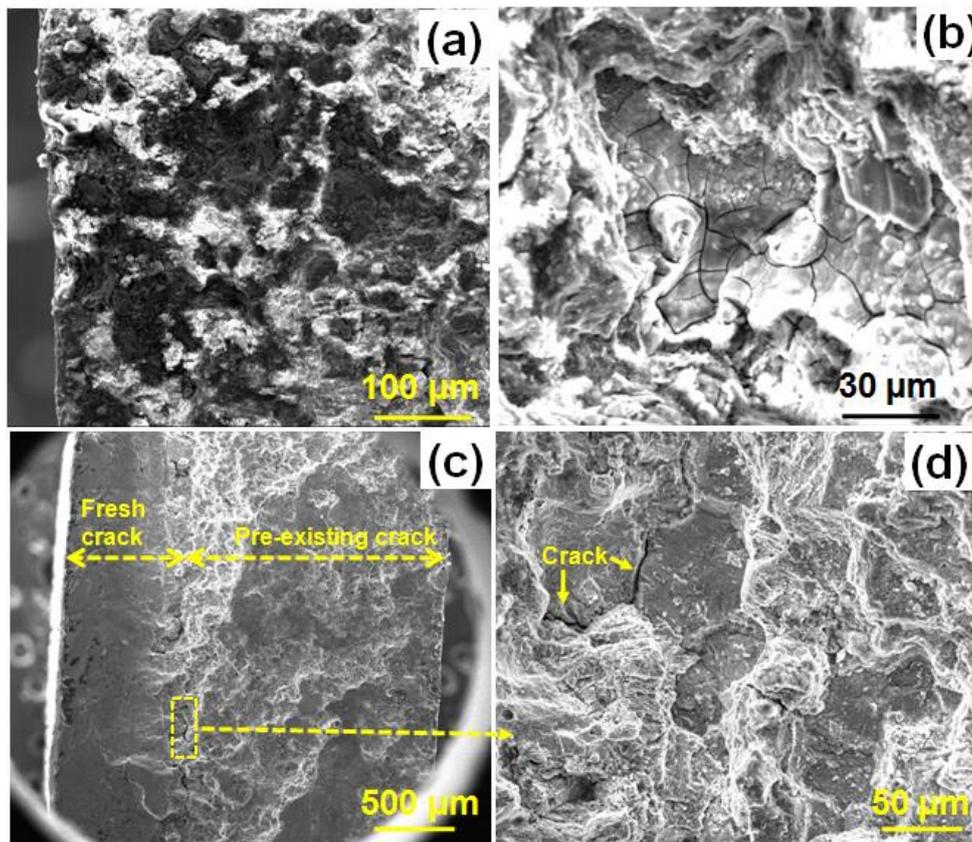
Figure. 4: SEM fractographs: (a) fracture features from dark region, (b) magnified image of (a) reveals several mud cracks, (c) fracture surface of entire fracture surface with distinct regions and (d) magnified image of (c) from mating surface between dark and bright regions.

SE images of fracture surface corresponds to entire fracture area has been examined and the fractographs taken at different magnifications are shown in Fig. 4. The fracture characteristics of dark region are quite different from that of the bright region. Specifically, thick layer of contaminated foreign material has masked over the dark region of fracture surface (Fig. 4a). Magnified micrograph of the dark region demonstrates extensive mud cracks which are typical of corrosion derbies (Fig. 4b). On the contrary, bright region of fracture surface reveals cleavage facets (Fig. 4 c and d). It also illustrates grain boundary cracks close to the mating surface between dark and bright fracture regions (Fig. 4 c and d).

The surface of the lock ring has suffered severe pitting corrosion as evidenced by metallography and EPMA studies. Several branching cracks are found propagating from the corrosion pits into the material which point towards the occurrence of stress-corrosion cracking (SCC). Dark contrast with mud cracks on 75% of the fracture surface reflects that these cracks were open to corrosion environment during service. The EDS results also confirm the same. SEM micrograph of the fracture surface exhibits extensive mud-cracks which has masked the most of the fracture features (Fig.4 b). These mud-cracks are the characteristics of drying out of hydrated, probably gel-like deposits. Hence, mud-cracks are typically termed as corrosion debris. In addition mud-crack pattern can usually be seen on fracture surfaces caused by SCC and SEM fractography study is required to see the mud-crack pattern in most cases [5]. The fracture region close to mating surface of pre-existing crack and newly formed crack reveals cleavage facets (Fig. 4 c and d). This indicates that the material has failed in brittle manner. Interestingly, cleavage mode of brittle fracture feature is one of the characteristic of SCC [6].

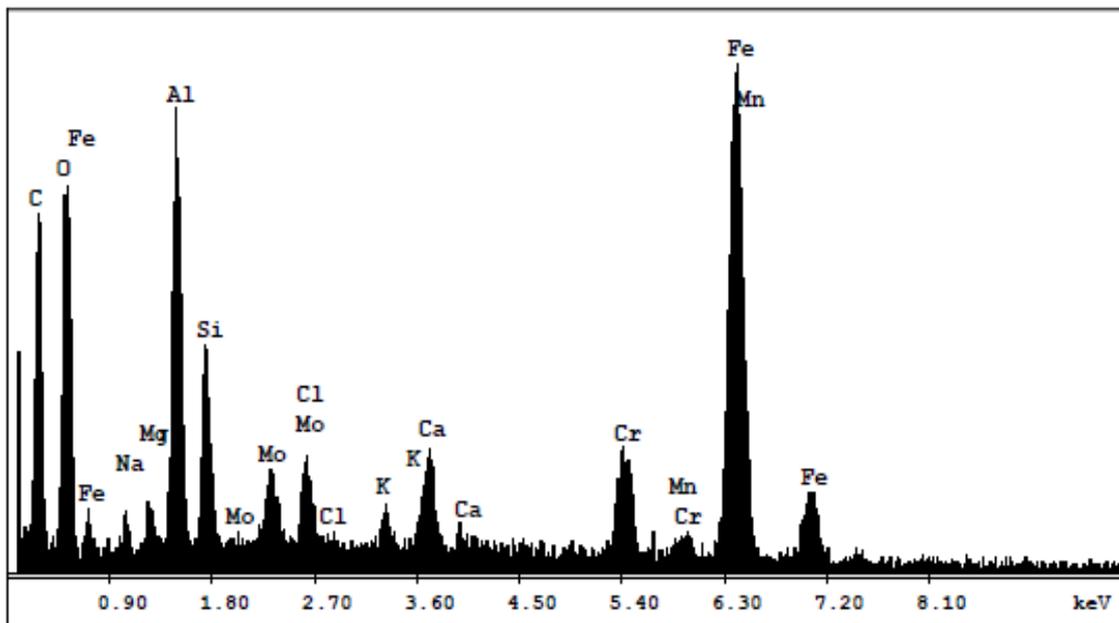
EDS analysis was carried out on the dark region of the fracture surface. The EDS spectrum reveals the presence of C, O, Ca, Cl, Na, Mg, Al, Si and K along with elements pertaining to parent material (Fig. 5). This also confirms that the dark fracture region is enveloped with corrosion products.

Figure. 5: EDS spectrum of the dark region of fracture surface showing corrosion products along with major elements of parent material.

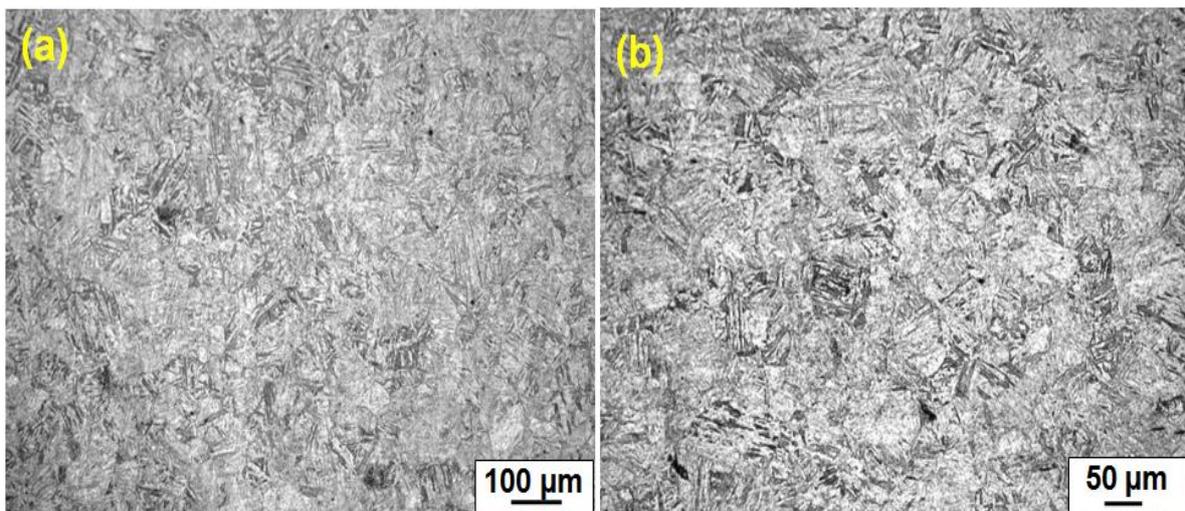
Longitudinal samples prepared from plane surface of failed lock ring exhibits typical tempered martensite structure in-etched condition (Fig. 6). The microstructure of the samples close to fracture surface in un-etched condition is shown in Fig. 7. Surface close to outermost edge exhibits surface pitting at several locations. It indicates that the material was degraded during service and also part of the same has dislodged from the parent material due to localized pitting. The formation of pitting is quite severe at the surface than that of the interior of the lock ring.

Figure. 6: Microstructures showing tempered martensite: (a) low and (b) high magnifications.

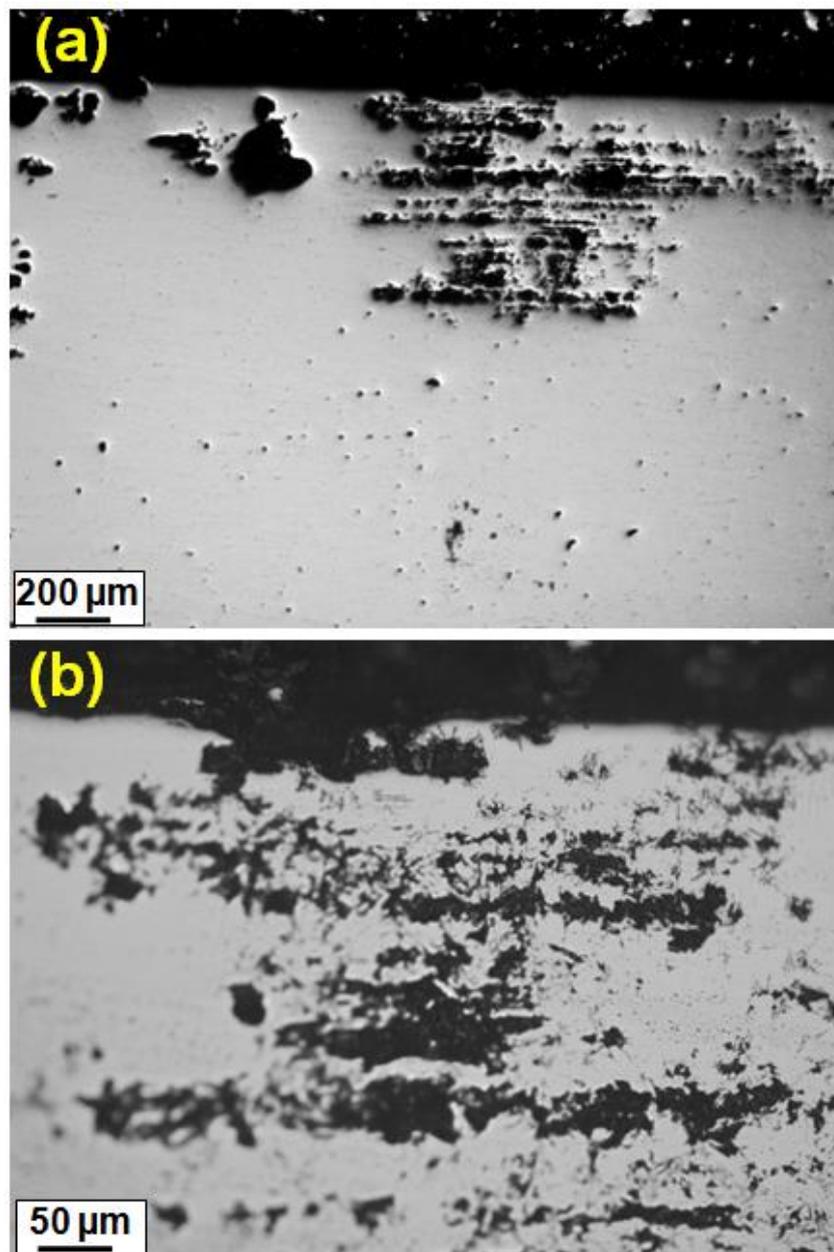
Figure. 7: Optical microstructures of failed lock ring close to surface exhibits pitting cavities in un-etched condition: (a) low and (b) high magnifications.

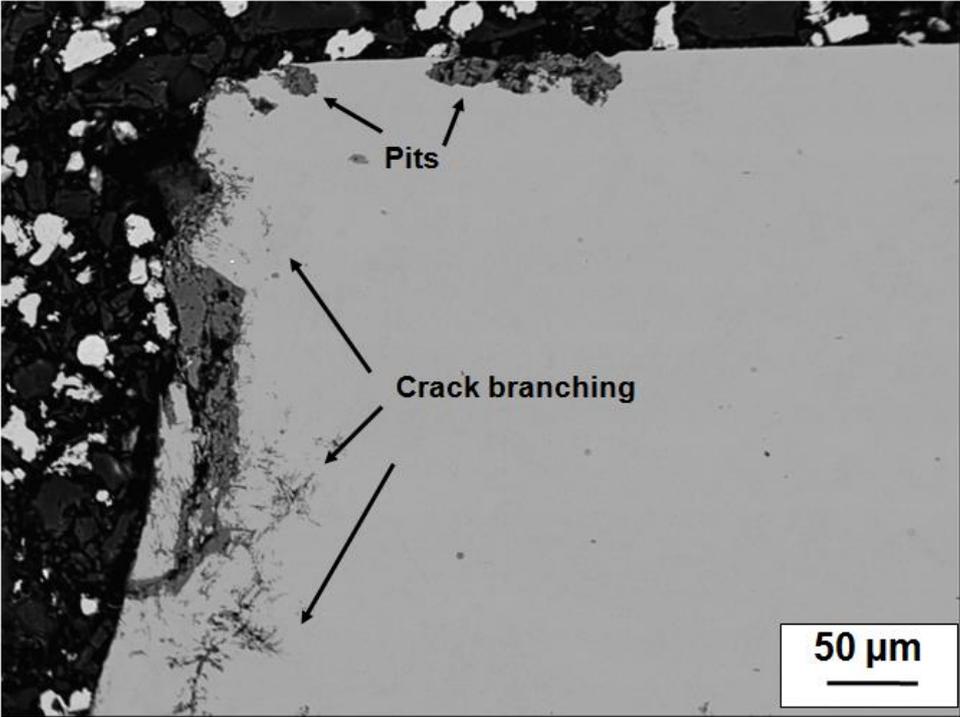
Back scattered electron images obtained from the failed lock ring close to fracture region demonstrates extensive pitting at several locations near the top surface (Fig. 8). These features are similar to those observed in optical microscope. This also confirms that the material has undergone pitting corrosion which has initiated at the surface. In addition, the cracks which are originated from the plane surface of its width side have further propagated into the base material along with several branches (Fig. 8). Low magnification BSE image obtained for entire width of the failed lock ring part exhibits abundant number of cracks with multi-branching. These cracks are extended towards inside the material (Fig. 9a). Magnified microstructures taken from three different regions of Fig. 9a clearly indicate that the cracks have propagated arbitrarily into different directions and formed tree like branching (Fig. 9 b-d). As a result, part of the base material has also dislodged from the affected area.

Figure 8: EPMA-BSE image at crack tip of the failed lock ring.

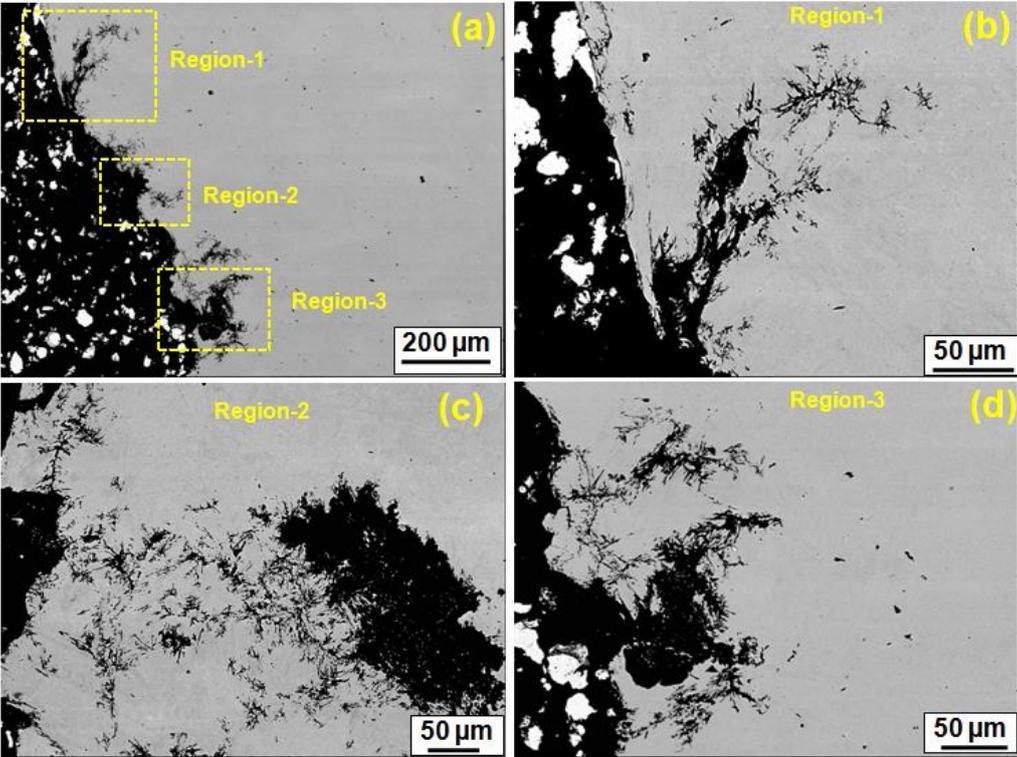
Figure 9: EPMA-BSE images: (a) low magnified image for entire width of failed ring, (b), (c) and (d) magnified images obtained from different region of (a).

As the lock ring is utilized to lock the blades in 4th stage compressor rotor, it has been subjected to continuous tensile stress during operation. In addition, the environmental condition during operation/service might have provoked to initiate stress corrosion. Thus the failed lock ring exhibits several tree like branched cracks which have been initiated from surface and then propagated inside the material. This has subsequently broken the lock ring into two pieces. Similar type of tree branched cracks have been observed for the stainless steel material failed due to stress corrosion cracking [11].

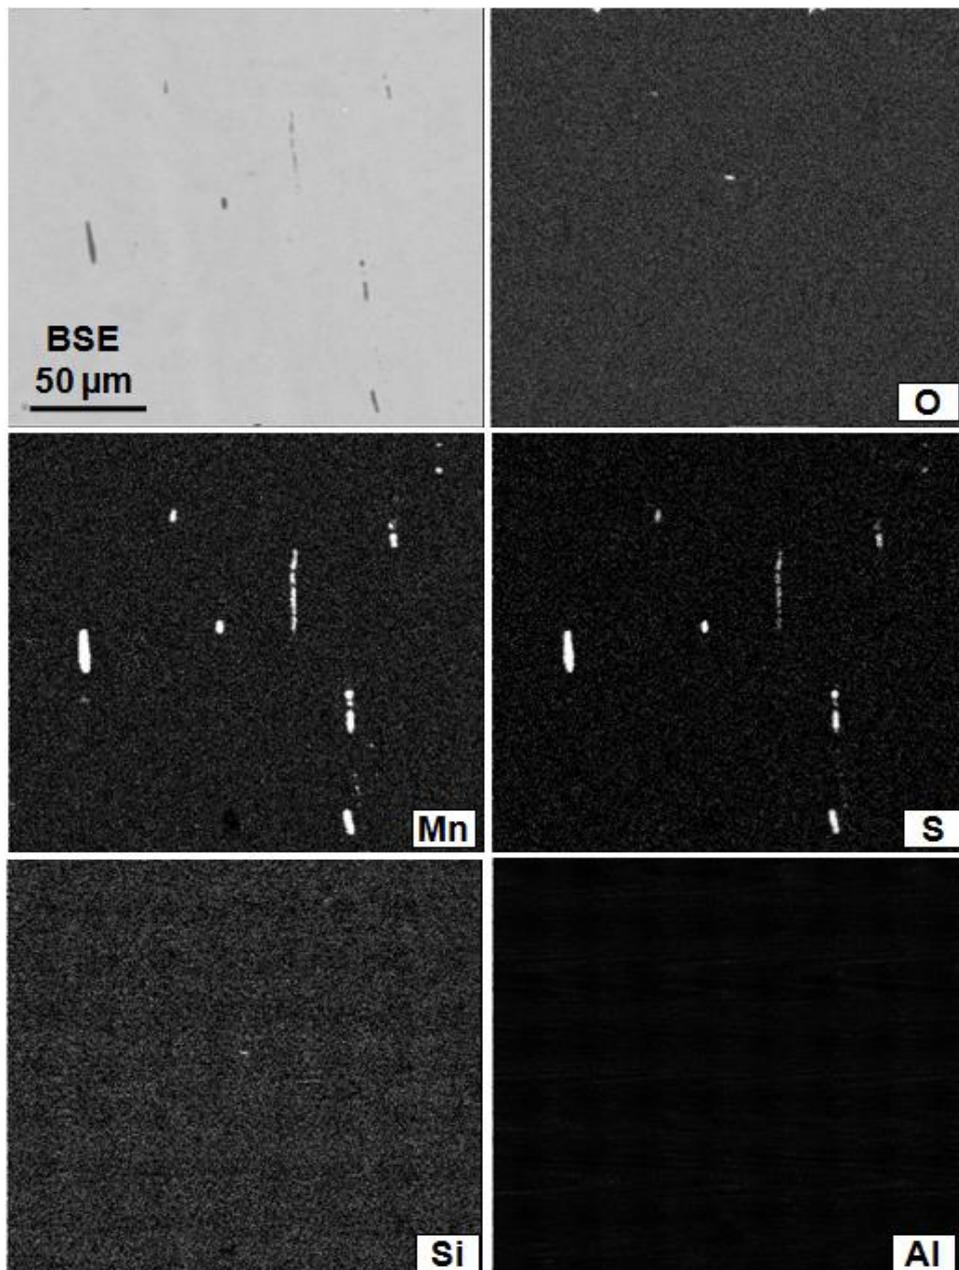
BSE image of failed lock ring exhibits the presence of both the elongated as well as globular inclusions. In order to identify the type and its morphology, X-ray elemental distribution mappings are obtained at three different regions and shown in Figs. 10-12. The base material reveals elongated manganese sulphide inclusions (Fig. 10). These MnS inclusions are elongated along the rolling direction and are located as bunch of inclusions within the area of about $200 \times 200 \mu\text{m}^2$ area.

Figure. 10: EPMA X-ray elemental distribution mappings of the elements Mn, S, O and Al.

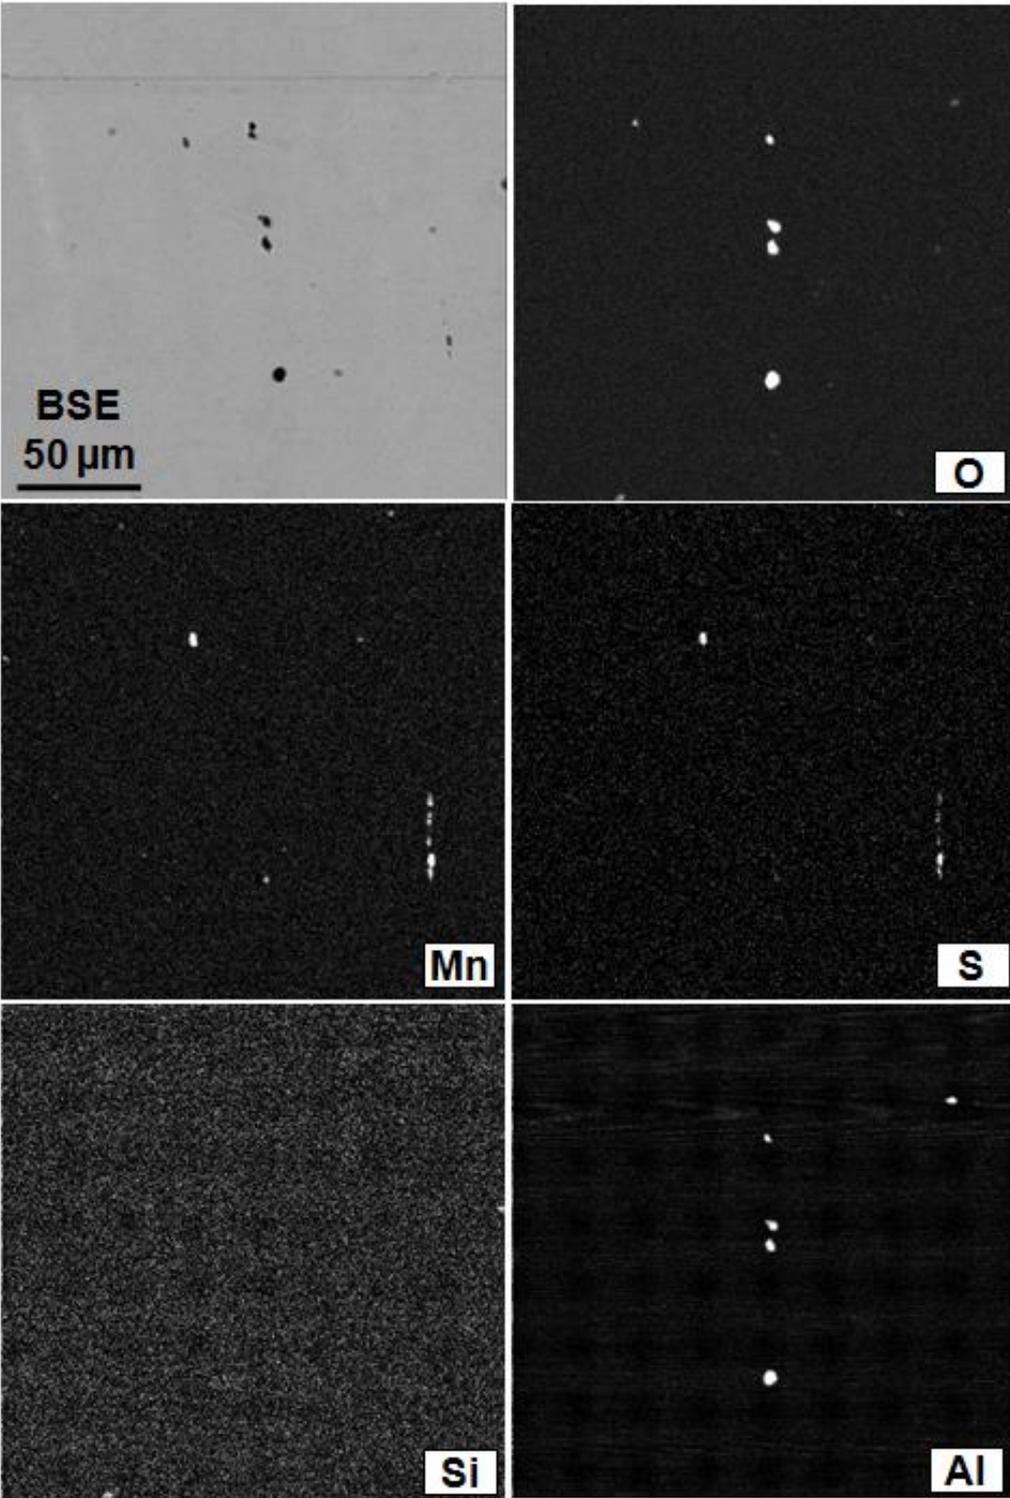
Another set of X-ray elemental distribution mappings has been taken from the region wherein both the elongated and globular inclusions are present. These mappings reveal the enrichment of O, Al and Mn, S elements, respectively (Fig. 11). This reflects that the MnS and Al_2O_3 types of inclusions are predominantly present in the material. X-ray mappings are also gathered from the region wherein both the types of inclusions are imbedded as single identity. It clearly illustrates that globular oxide inclusion is encapsulated with elongated MnS (Fig. 12). The MnS inclusion is elongated and located at the periphery of the Al_2O_3 . EPMA analysis shows that the parent material used for lock ring contains predominantly MnS as well as Al_2O_3 types of inclusions.

Figure. 11: EPMA X-ray elemental distribution mappings of the elements Mn, S, O, Si and Al.

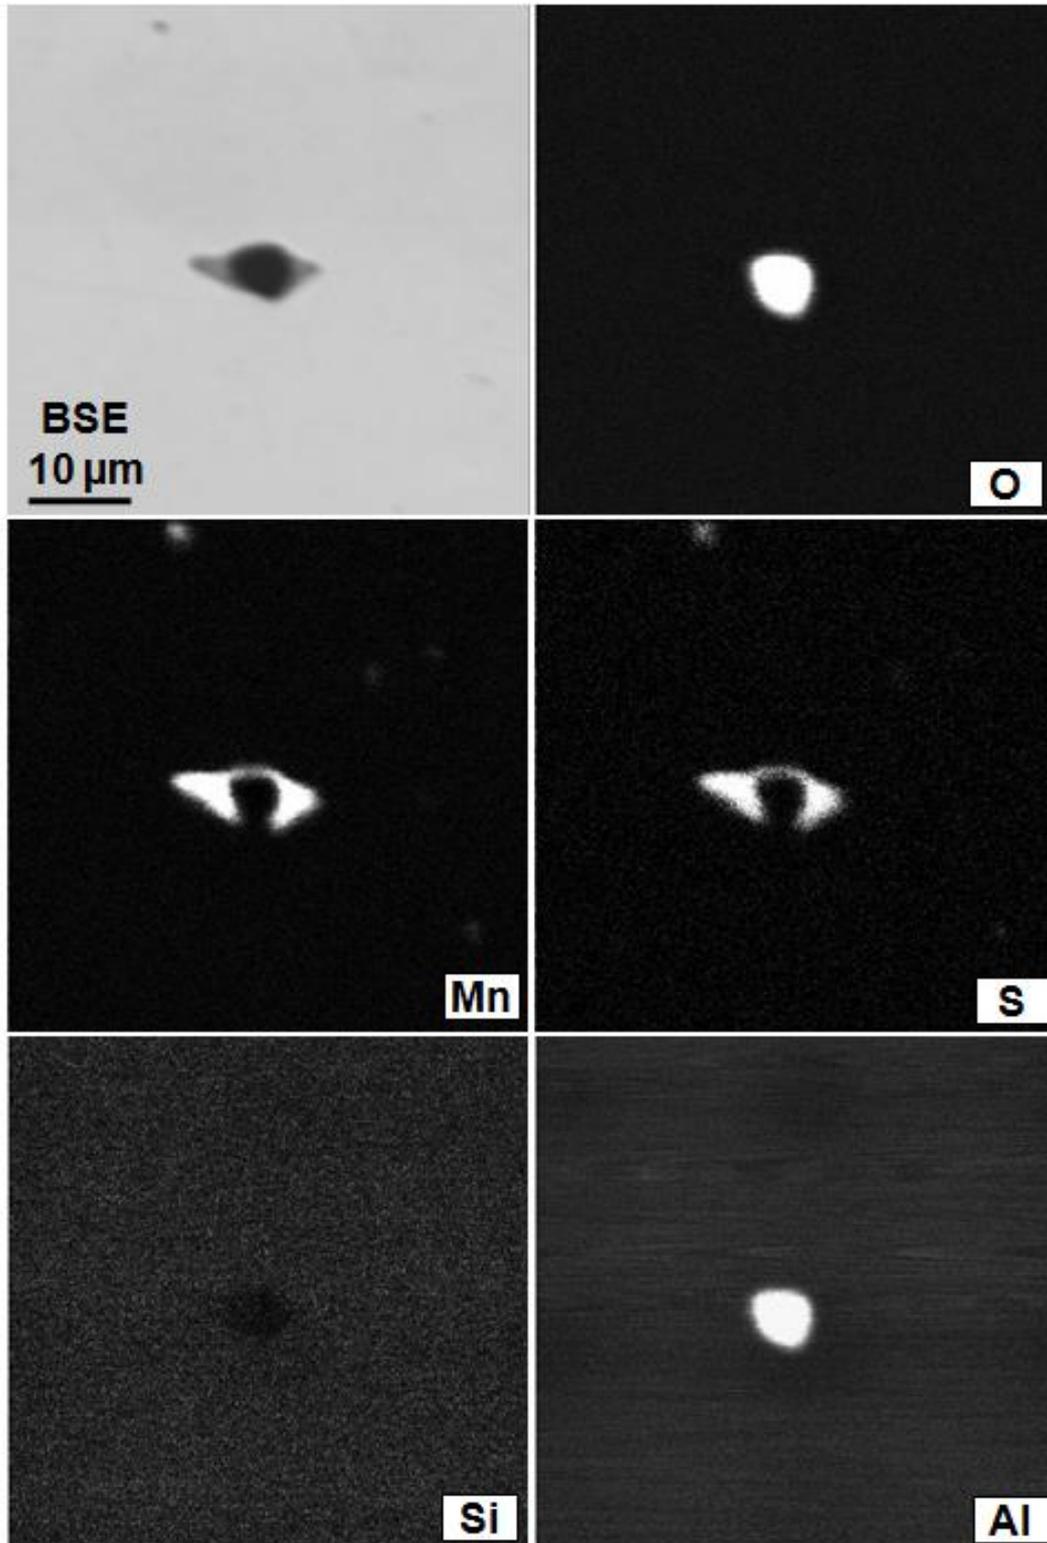
Figure. 12: EPMA X-ray elemental distribution mappings of the elements Mn, S, O, Si and Al.
