Failure Analysis of Bolt of Rear Mounting Trunion of an Aero-Engine: A Case of Bending Induced Chevron Pattern as well as Fatigue Failure on the Same Fracture Surface

Mrityunjoy Hazra and Ashok Kumar Singh

Present work describes the failure investigation of failed bolt of starboard rear mounting trunion of an aero-engine. Multiple fracture initiation points are noticed. This is a classic case of a single bending type of load initiating reversed bending fatigue as well as chevron pattern on the same fracture surface. Visually observed bending phenomenon supports the each type of failure mode. More interestingly, point of initiation of fast as well as the reversed bending fatigue failure is the same, although those two events have been found to be separate phenomena. It has been established that two different fatigue crack fronts, typical of reversed bending fatigue phenomenon propagated towards each other to make half of the cross-section fractured, while the another half failed by chevron patterned fast fracture. In this, the fast fracture of one half has preceded the reversed bending fatigue fracture of the other half, although the former is not responsible for happening of the

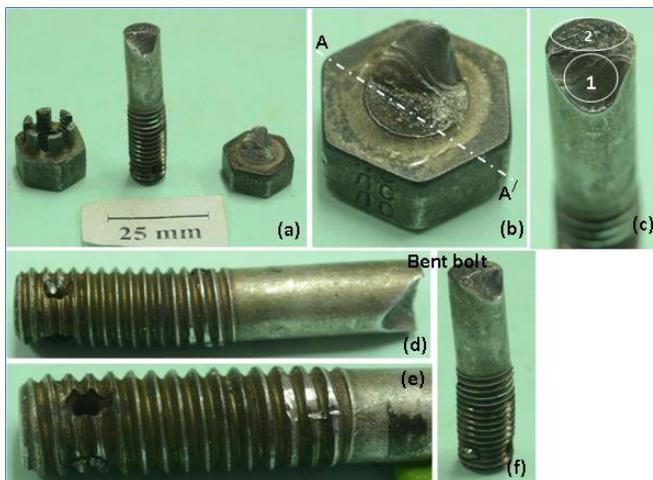
The photographs (at various orientations) of failed parts in as-received condition are shown in Fig. 1. Marked pieces 1, 2 and 3 represent undamaged nut, bent and failed shank portion of the failed bolt along with failed and detached bolt head parts, respectively. Bending is vividly revealed in bolt shank part (Fig. 1 (a, d-f)).

Fig.1: Photographs of as-received failed components.

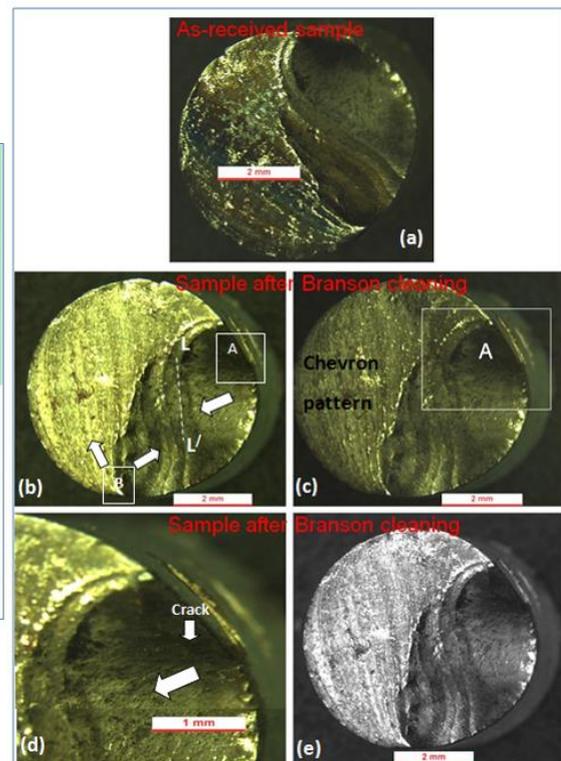
Stereo microscopic images of the shank fracture surface are displayed in Fig. 2. As-received surface is shown in Fig. 2a, while Fig. 2 (b-e) represents Branson cleaned surface. Various illuminating conditions and light intensities have been used with the fracture surfaces shown in Fig. 2 (b-e) as deemed appropriate to reveal fracture features. Points A and B appear to be two important fracture junctions with respect to initiation of the fracture surface under fatigue loading. Point B initiates another crack front distinguished by typical Chevron pattern. Arrows in Fig. 2 (b and d) indicate the propagation directions of the cracks.

Figure 2: Stereo microscopic images of failed bolt shank part in various illuminating and cleaning conditions: (a) acetone and (b-e) Branson cleaned conditions.

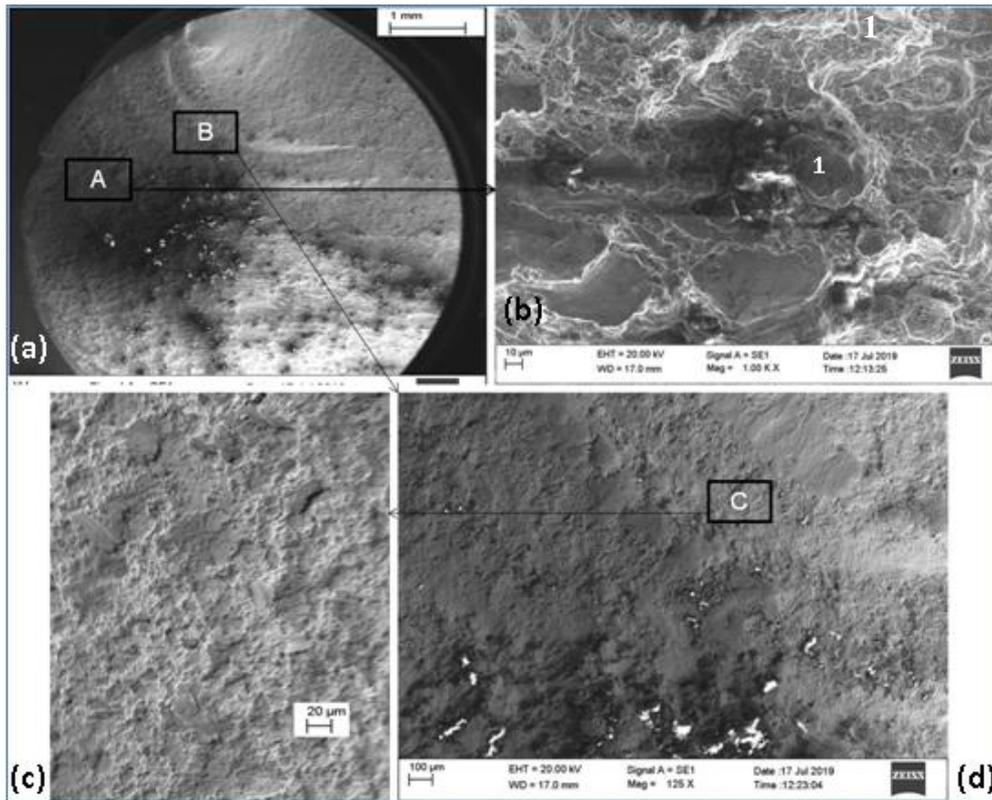
SEM images of the shank fracture surface after acetone cleaning is exhibited in Fig. 3, as taken from top of the fracture surface. Right side plain region of the surface of Fig. 3a corresponds to the region 1 in Fig. 1, while the remaining rough region beside that one is region 2 in Fig. 1. Extensive rubbing has been noticed in both the regions (Fig. 3(c and d)). Quasi-cleavage fracture has been observed in region 2. Cadmium has been found to exist in major area of region 2 (Fig. 3 (a and b)). This has been confirmed by the EDS analysis (Fig. 4). The fracture surfaces of bolt head are displayed in Fig. 5. Magnified image of region A (region B in Fig. 2) is displayed in Fig. 5b. Localized notch and few cracks seem to have been present along the periphery in this region. Crack marked in Fig. 5b is basically the same location of the bolt shank part as is the location A in Fig. 2b. However, no corrosion pits and / or corrosion debris is found. Rough region B displays the presence of cadmium (white patches in Figs. 5c and 6), similar to that observed on the mating bolt shank fracture surface (Figs. 3 (a and b) and 4).

Fig. 3: SEM fractographs of failed bolt shank in acetone cleaned condition

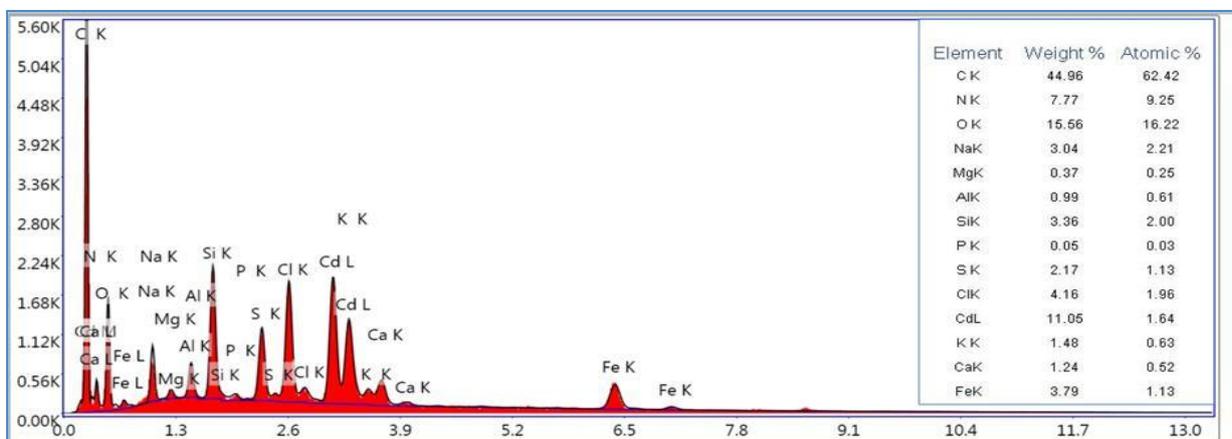
Fig. 4: EDS pattern taken from the point 1 in Fig. 3.

Fast fracture region in acetone cleaned condition contains significant amount of cadmium and oxygen along with sulphur, chlorine, sodium, potassium and calcium (Figs. 3 and 4). Another location of the same fracture region contains cadmium and iron with significant amount of oxygen and small quantity of calcium (Figs. 5 and 6). On the other hand, fatigued region is found to contain either almost pure cadmium or cadmium with oxygen (Fig. 7). Elements such as sulphur, chlorine, sodium, magnesium and calcium are often found to be there along with cadmium and oxygen. These findings indicate that the corrosion of cadmium plating may have happened, although the evidence of bolt corrosion is rather not sufficient.

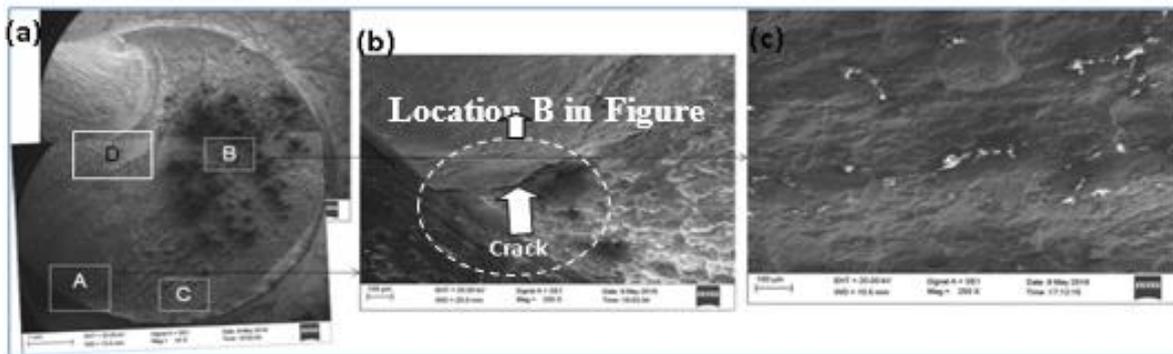
Fig. 5: SEM fractographs of failed bolt head in acetone cleaned condition.

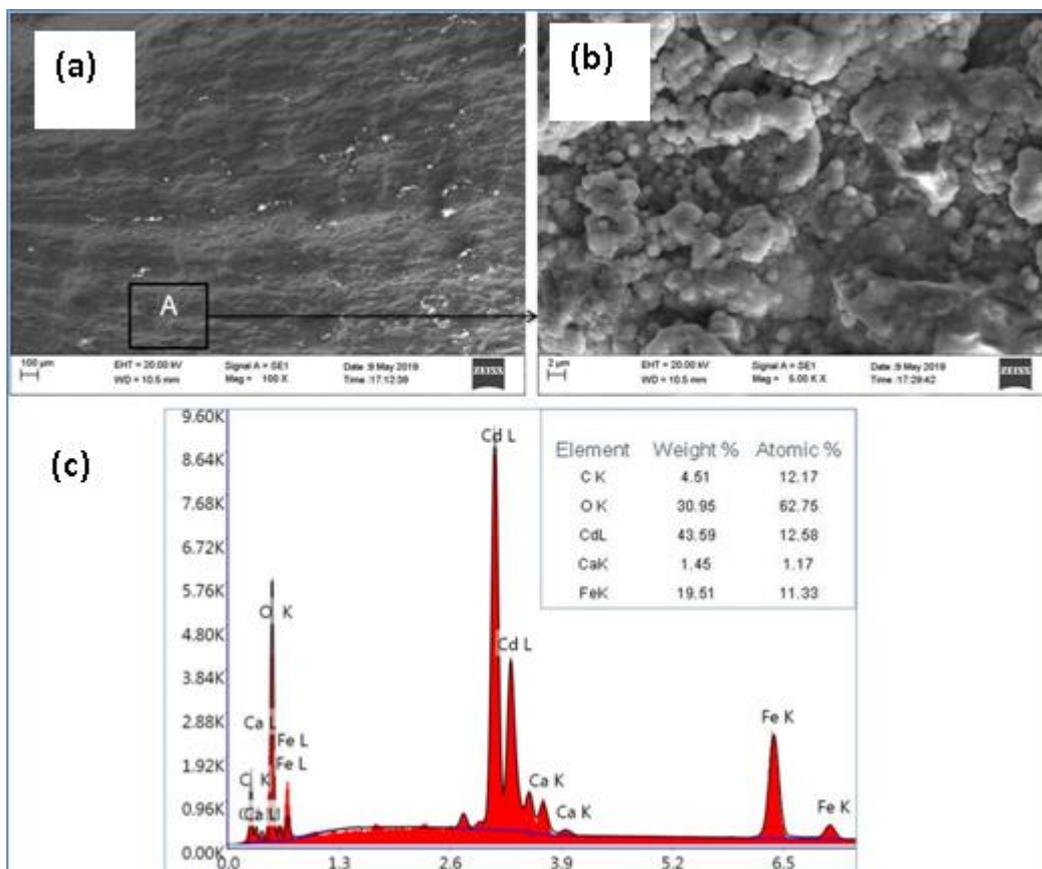
Fig. 6: High magnification images of region C (in Fig. 5a) showing presence of tiny cadmium particles, (b) high magnification image of the region A (marked in (a)) and (c) EDS pattern taken from tiny particles.

High magnification image of apparently clean region C is presented in Fig. 6. Cadmium has been found to exist as tiny round particles even here. Fig. 7 displays high magnification image of a typical area of region D in Fig. 5 (region 1 in Fig. 1c). The EDS patterns are taken from various locations (1, 2, 3 and 4) and results are presented in Fig. 7. Cadmium has been found even in some areas of this region (especially location 1), while few other areas reveal the presence of corrosion debris (locations 3, 4 in form of Fe-O) and base material (location 2).

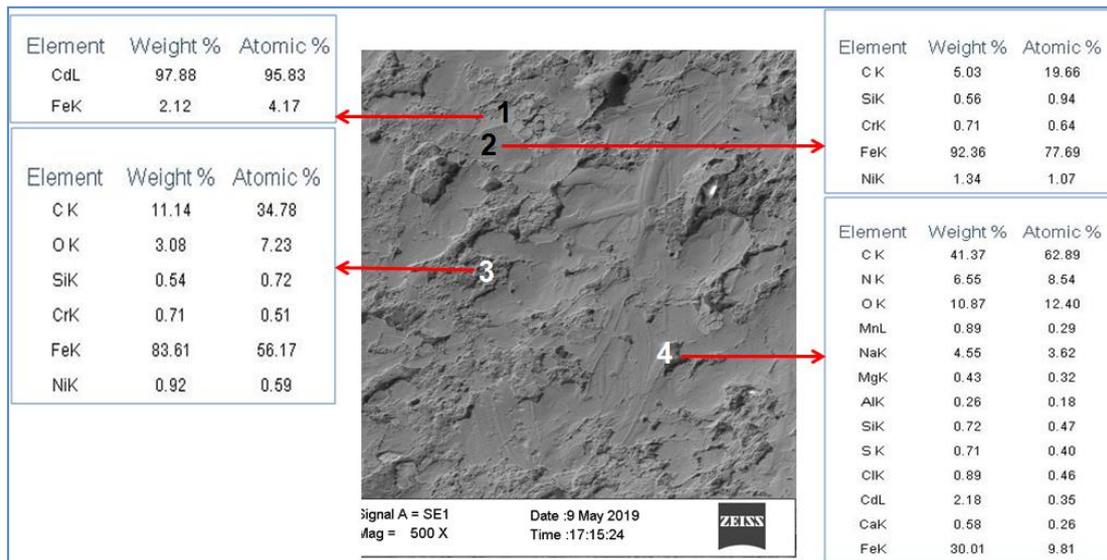
Fig. 7: High magnification images of region D in Fig. 5a and (b-e) EDS data taken from the locations 1, 2, 3 and 4. The fracture surface of failed bolt shank is shown in Fig. 8 after Branson cleaning. Cadmium is not found in region 2 after this cleaning. This reveals the presence of micro-cracks throughout the rubbed fracture surface.

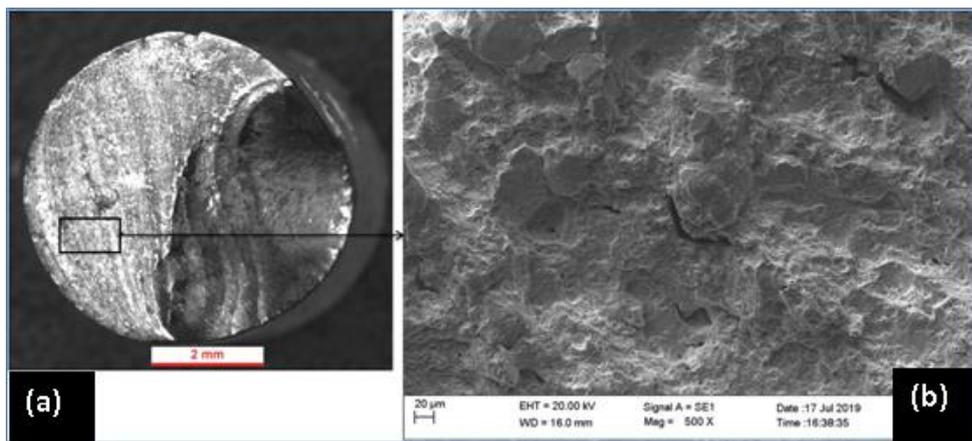
Fig. 8: SEM fractographs of failed bolt head in Branson cleaned condition.

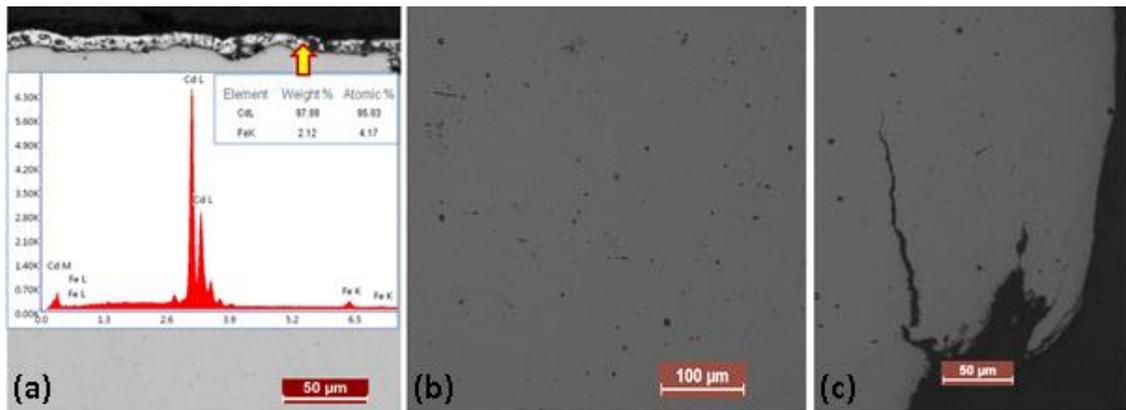
Metallographic sample was extracted from the fracture surface along plane A-A' in Fig. 1b. Un-etched optical microstructure of the sample shows the presence of cadmium coating, as confirmed by corresponding EDS pattern (Fig. 9a). Fig. 9b exhibits the presence of oxides and few sulphide stringers. A well revealed crack and many other small cracks are found in the sample (Fig. 9c).

Fig. 9: Optical micrographs of the failed sample in un-etched condition: (a) presence of cadmium coating at the surface as supported by SEM EDS pattern, (b) oxides and sulphide stringers in microstructure and (c) cracks starting from the fracture surface.

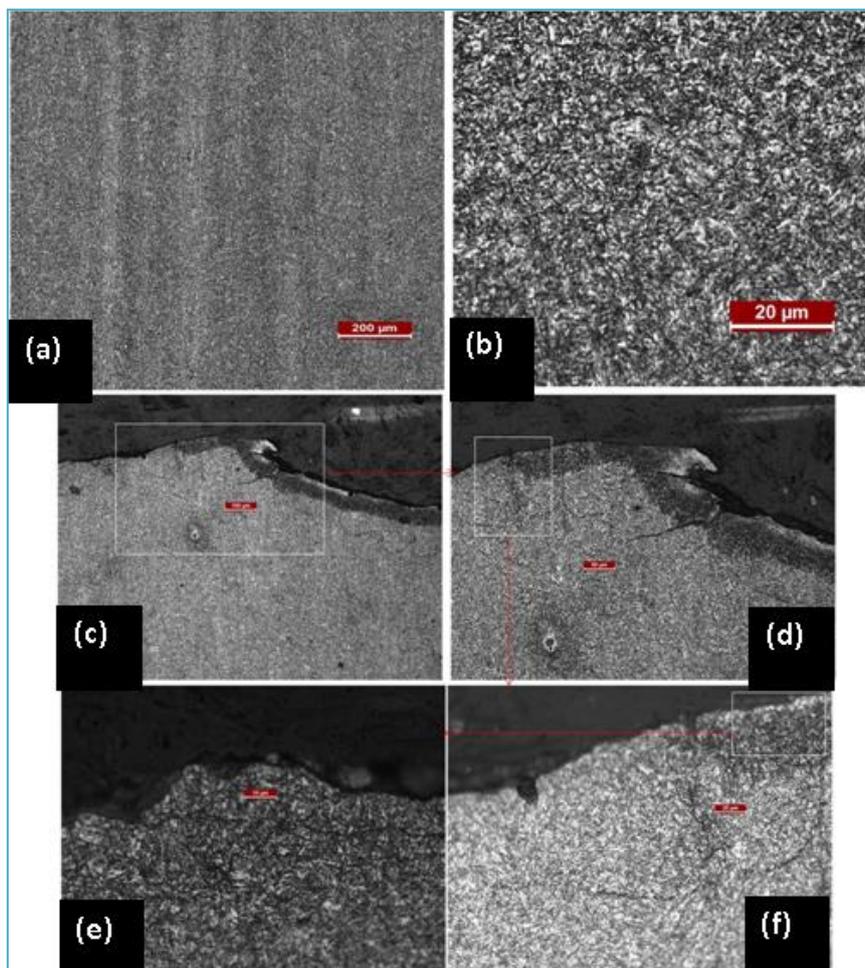
The microstructures in etched condition are presented in Fig. 10. This clearly reflects the presence of banding (Fig. 10a). High magnification micrographs show the presence of tempered martensite. Many small cracks and crack like appearances are observed in the microstructure at periphery of fracture surface.

Fig. 10: Optical micrographs of the failed sample: (a) banding and (b-f) tempered martensite structure along with few peripheral cracks. Etchant: 3% nital.
