## Microstructural Characterization of Failed Aircraft Antenna

This paper presents the failure analysis of aircraft antenna which is a sub-assembly of Traffic Collision Avoidance System (TCAS) used with Air Traffic Control (ATC) transponder. The base of the damaged antenna (metallic part) is made from Al-based alloy. The micrographs exhibit the typical solidification microstructure consisting of Al-rich matrix along with Si- and Mg-Si-Fe- rich phases. The antenna is coated with the paint consisting of three layers. First and third layers display the presence of Ti and C while second layer consists of Si, Cr and C elements. The small amount of oxygen is also present in all the three layers. The cracks are appeared in the central region of the fin due to impact of external objects (appears to be blankings and particles). Three types of foreign object damage particles are observed on the damaged / hit area. The antenna appears to be damaged during gale as a result of hitting of the large particles lying in aircraft parking area and aircraft engine blankings.

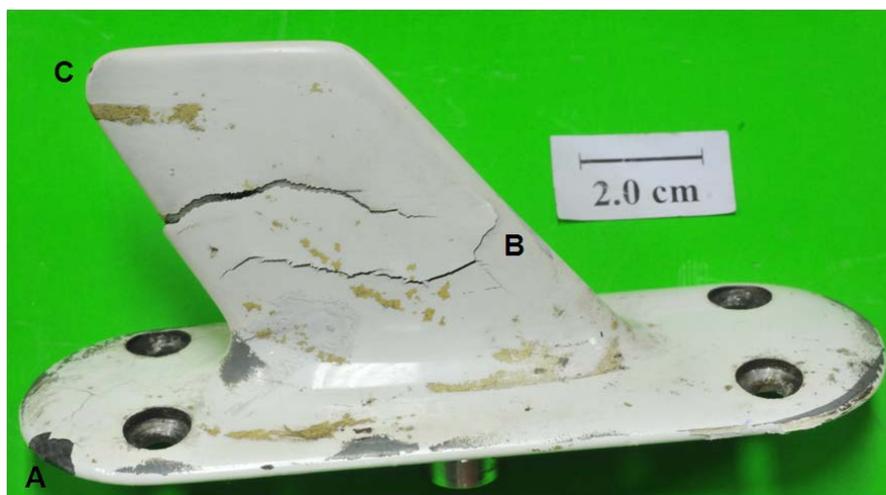
The photograph of the damaged antenna in as-received condition is shown in Fig. 3. This clearly shows that the component has impact marks at the three distinct locations marked by **A**, **B** and **C** (Fig.3). The enlarged views of these locations are shown in Fig. 4 (a-c) corresponding to **A**, **B** and **C** locations (Fig. 3), respectively. It appears that a hard object has hit the antenna at these locations. As a result, paint layer has either come out (Figs. 4 (a and c)) or peeled off (Fig. 4b). The hits at points **A** and **C** have created dent marks. The areas near point **B** have not displayed dents but the removal of paint layer only (Fig. 4b). There appears to be thin layer of paint applied at the base of the fin in the past during servicing.

The impact at **A** caused some damage to base of the antenna while the impact at **C** that happened to be the tip of the fin resulted in severe cracking in the middle of the fin due to bending forces created by impact of the high velocity object. The paint of the antenna is very hard and not easily scratched or damaged. This has been tested by hammering at the base of the antenna. The removal of paint at the tip of fin in Fig. 4c therefore indicates that the fin has been hit by a quite hard object. This has resulted in damage observed in antenna. In addition, antenna also displays multiple cracks initiated from one end to other of the fin (Fig. 3). The high magnification photographs of these cracks are shown in Fig. 4 (d-f). These cracks are quite deep and appeared on both the side of antenna (Fig. 4 (d-f)).

Figure 3: The photograph of the damaged antenna in as-received condition.

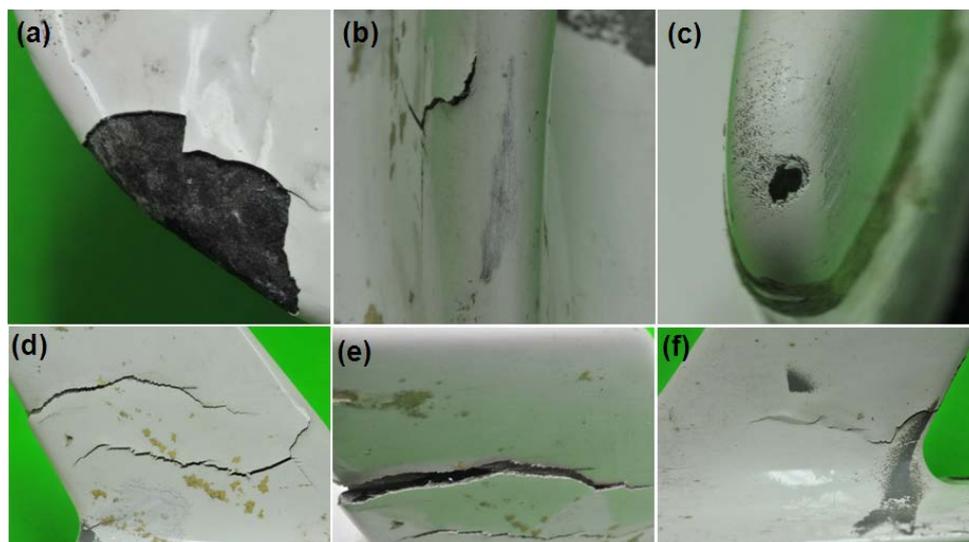
**Figure 4:** (a), (b) and (c) are corresponding to enlarged views of the **A**, **B** and **C** locations (Fig.3) displaying impact marks; (d), (e) and (f) are enlarged views of the antenna exhibiting multiple cracks at middle of the fin.

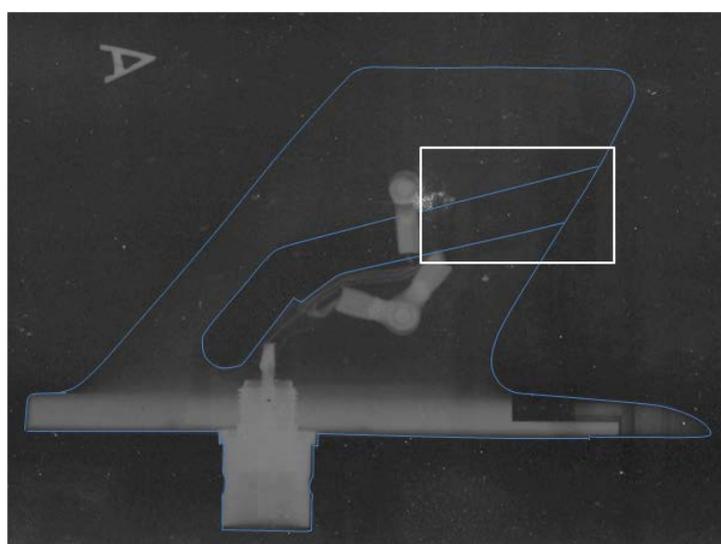
The X-ray radiograph taken from the damaged antenna is shown in Fig. 5. The blue lines are drawn on the radiograph to understand the internal structure of the component more clearly. The cracking observed is highlighted by white rectangular box (Fig. 5). The parallel blue lines shown in the white rectangular box indicate the presence of light material due to absence of contrast in radiograph of that region.

**Figure 5:** X-ray radiograph of the damaged antenna. Cracking area is indicated by white rectangular box.

Impact of the object with the antenna has removed paint only. No cracking is observed in the metallic part of the antenna. The X-ray radiograph of the damaged antenna reveals that the presence of severe cracking in middle part of the fin which is made up of a Si based material (Fig. 5). The cracks are appeared in the central region of the fin due to impact of an external object (appears to be blankings and particles in the present case). X-ray radiography observations also show that the fin has been cracked at locations where only Si based material is present inside the fin structure. Cracking observed is highlighted with the white rectangular box (Fig. 5). This can be attributed to hitting of the object at the top of the fin (location C of Fig. 3).

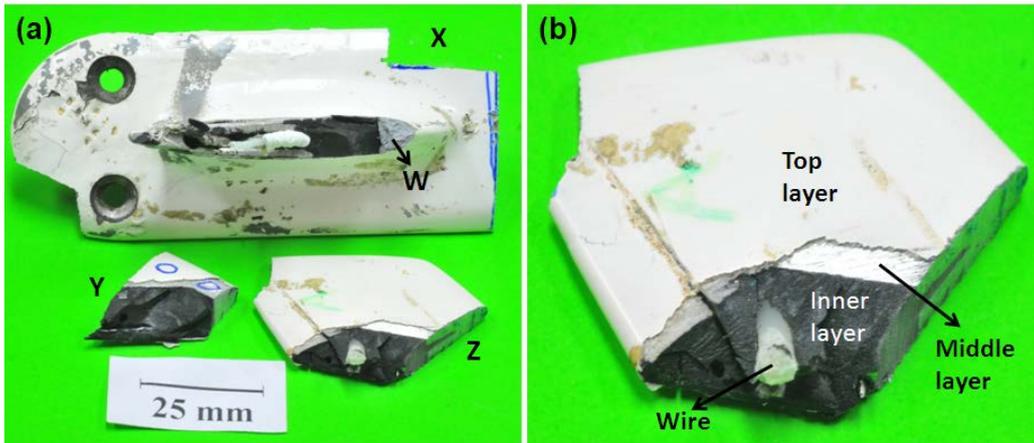
The damaged antenna is broken to see the internal structure and mode of fracture. The photographs of the broken pieces are shown in Fig. 6. These pieces are marked as X, Y and Z. The close view of piece marked as Z is displayed in Fig. 6b. The antenna consists of the three layers (top, middle and inner) as shown in Fig. 6b. The internal structure of the antenna also consists of the connecting wire (Fig. 6b).

**Figure 6:** Broken pieces of the damaged antenna: (a) all pieces together and (b) close view of the Z in (a).

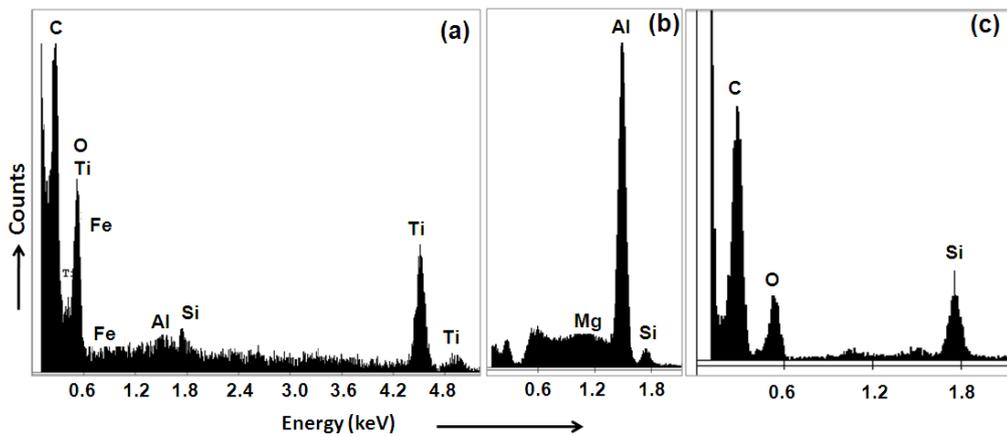
In order to know the layers compositions, the EDS analysis has been carried out at different locations of the Fig. 6b. The EDS patterns taken from the top, middle and inner layers are shown in Fig. 7 (a-c). The top layer exhibits the presence of C, O, Ti, Fe, Al, Si and Ti elements (Fig. 7a). This indicates the presence of the paint material. The EDS pattern of the middle layer displays the presence of Al, Mg and Si (Fig. 7b). The middle layer is basically an Al-based alloy. The inner layer exhibits the presence of Si, O and C (Fig. 7c). It reflects that the inner layer is made up of Si-based material.

**Figure 7:** The EDS patterns taken from: (a) top, (b) middle and (c) inner layers of the Fig.6b.

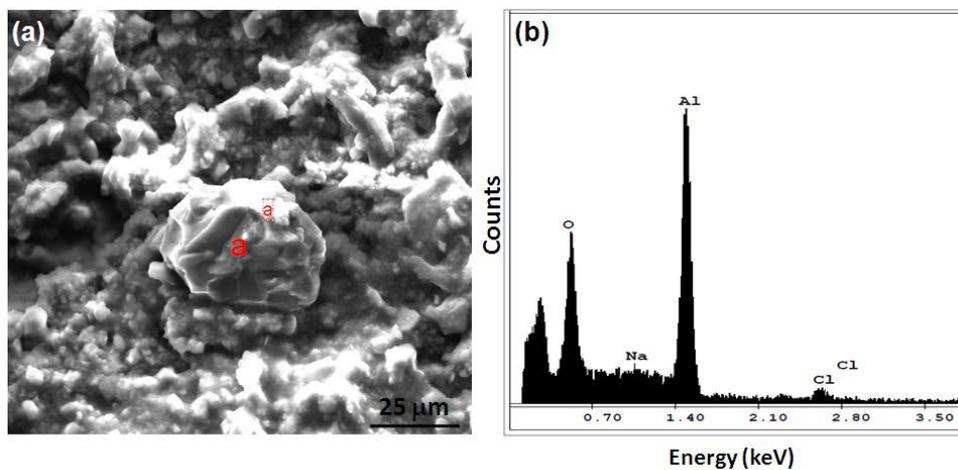
The dent mark at location A (Fig. 3) reveals the presence of several foreign particles. These particles are marked as **a**, **b**, **c**, **d** and **e** on the SE SEM (Secondary Electron (SE) mode in Scanning Electron Microscopy (SEM)) images and their corresponding EDS patterns are shown in Figs. 8-12. The particle marked as **a** is shown in Fig. 8a and corresponding EDS pattern is exhibited in Fig. 8b. The EDS pattern reveals the presence of Na, O and Cl along with

**Figure 8:** SE SEM image: (a) particle **a** in damaged portion of the antenna (location **A**) and (b) corresponding EDS pattern of particle **a**.

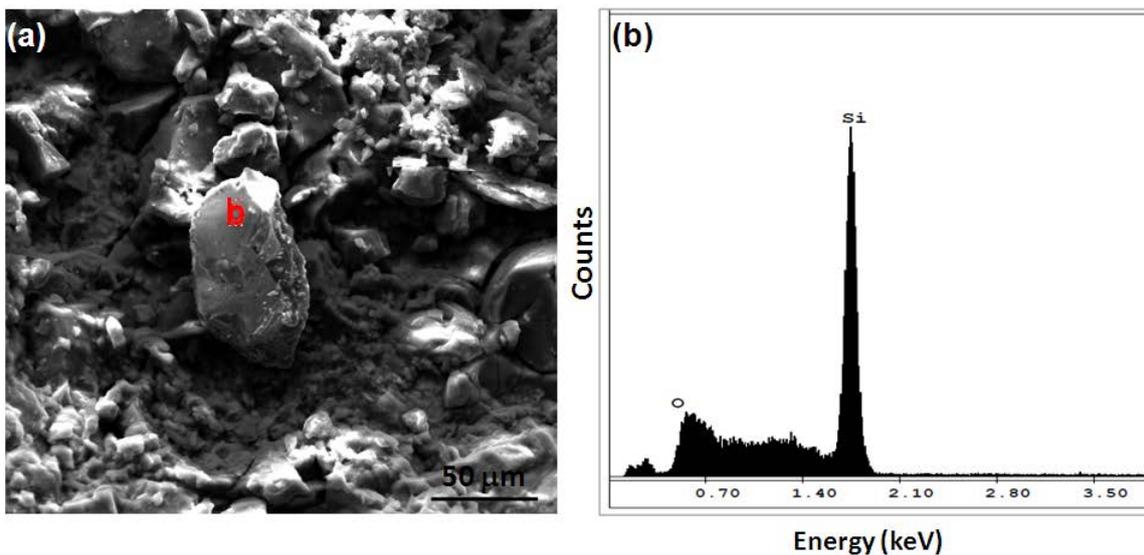
the base material Al. The particle **b** is shown in Fig. 9a. The corresponding EDS pattern is displayed in Fig. 9b. It exhibits the presence of O and Si indicating that the particle **b** is Si rich.

**Figure 9:** SE SEM image: (a) particle **b** in damaged portion of the antenna (location **A**) and (b) corresponding EDS pattern of article **b**.

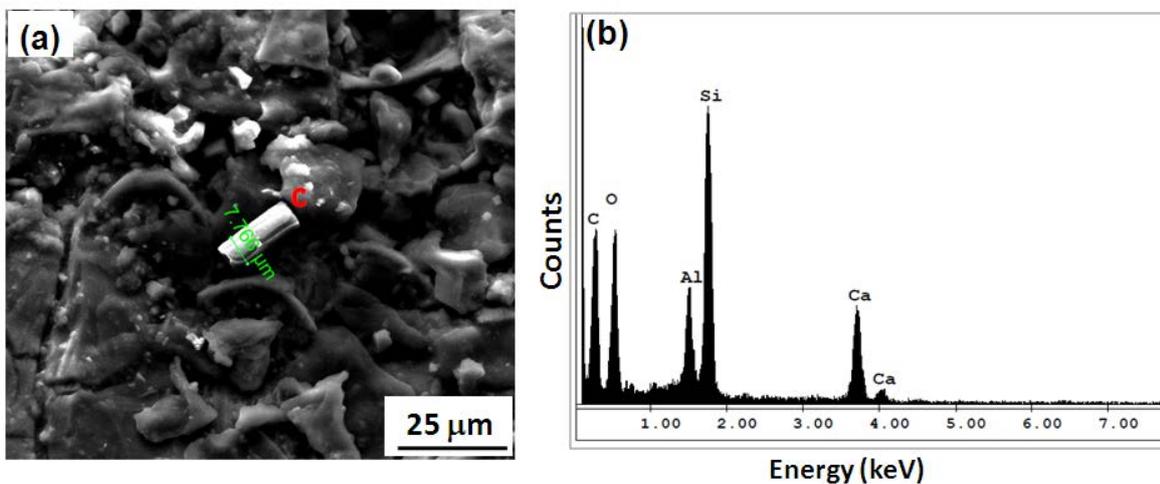
The SE SEM images showing fibre particles marked as **c**, **d** and **e** are shown in Figs. 10-12. The fibre particle **c** (Fig.10 (a and b)) exhibits the presence of C, O, Al, Si and Ca elements. Among these, the elements Al is from the base material. The large amount of Si in this particle probably appears partly from the base as well as from particles lying on the ground (aircraft parking area). The source of Ca appears to be from the later particles. The fibre particle **d** (Fig. 11 (a and b)) shows the presence of C, O, Mg, Al, Si and Fe. As mentioned above, the presence of these elements except Al are due to particles lying on the ground. The fibre particle **e** (Fig. 12 (a and b)) displays the presence of C, O, Al, Si and S. The elements like Mg, Al and Si form the particles **e** are from the base material.

**Figure 10:** SE SEM image: (a) fibre particle **c** in damaged portion of the antenna (location **A**) and (b) EDS pattern corresponding to fibre particle **c**.

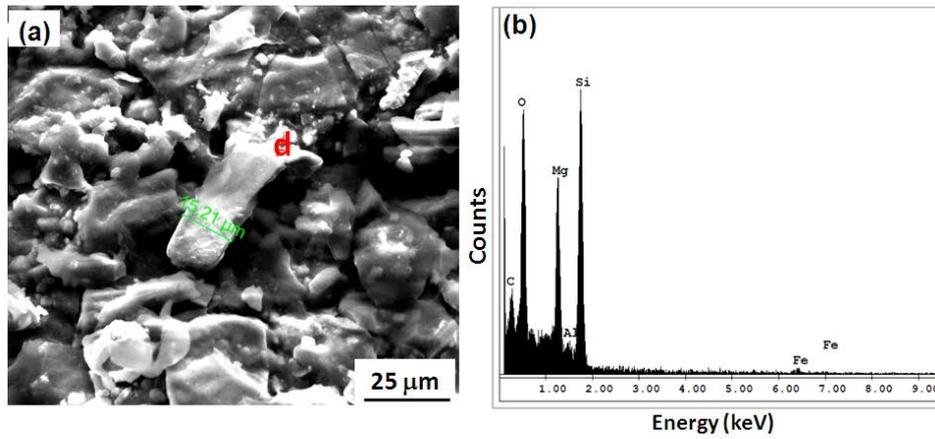
**Figure 11:** SE SEM image: (a) fibre particle **d** in damaged portion of the antenna (location **A**) and (b) EDS pattern corresponding to fibre particle **d**.

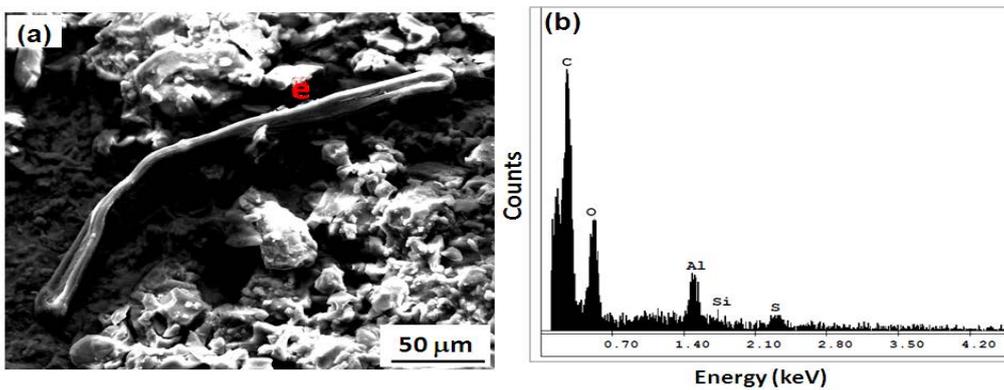
**Figure 12:** SE SEM image: (a) fibre particle **e** in damaged portion of the antenna (location **A**) and (b) EDS pattern corresponding to fibre particle **e**.

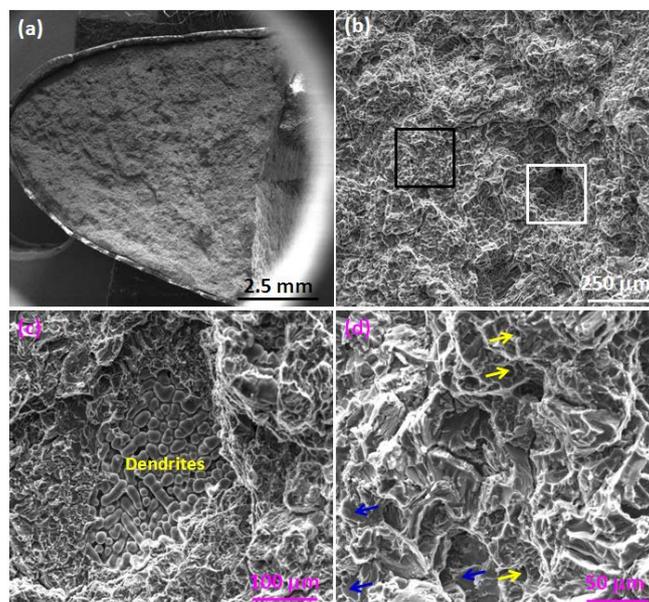
The fracture surfaces taken from the location marked as W (Fig. 6a) are shown in Fig. 13. The fracture surface exhibits the presence of two distinct features (Fig. 13b). These are marked with white and black square boxes. The high magnification images corresponding to Fig. 13b (marked with white and black square boxes) are shown in Fig. 13(c and d). The high magnification SE SEM image taken from the white square box (Fig. 13b) is depicted in Fig. 13c. This exhibits characteristic appearance of shrinkage casting dendrites. In addition, it also displays the presence of porosity. The high magnification SE SEM image taken from the black square box (Fig. 13b) is shown in Fig. 13d. The fracture surface exhibits the presence of dimples (marked by yellow arrows in Fig. 13d) and flat facets (marked by blue arrows in Fig. 13d). The type of fracture is mixed mode.

**Figure 13:** The fracture surfaces of the location **W** of the Fig. 6a: (a) low and (b) high magnifications. Different features in (b) are shown as square white and black boxes; SE SEM high magnification images of Fig. 13b corresponding to regions marked with: (c) white and (d) black square boxes.

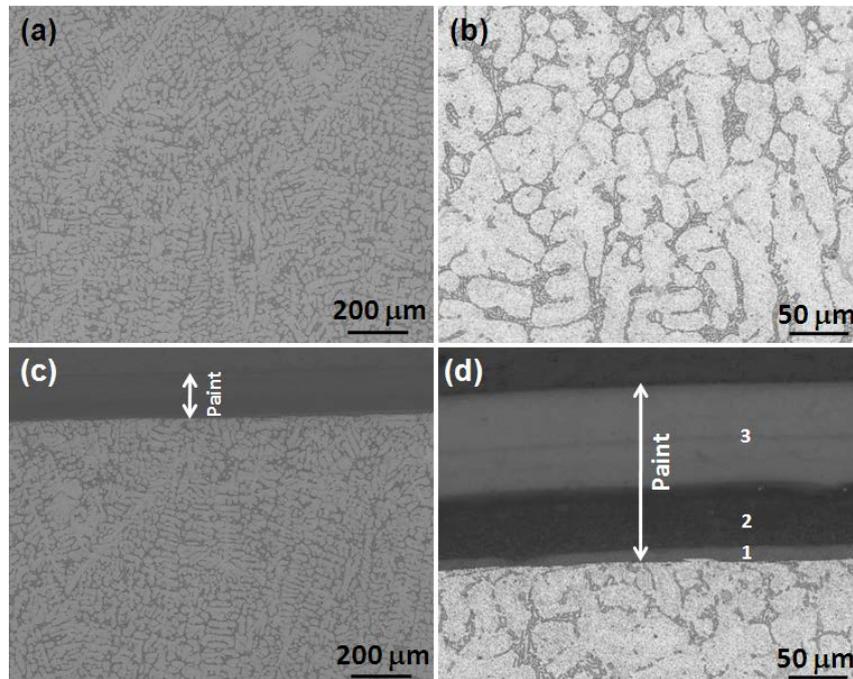
The chemical composition of base of the damaged antenna (metallic part) determined from EPMA is shown in Table 1. This indicates that it is made from Al-based alloy. The optical microstructures of the as-received base of the antenna exhibit the typical solidification microstructure (Fig. 14). It displays the presence of two phases namely, primary  $\alpha$ -Al phase with dendrites surrounded by the eutectic Al-Si (Fig. 14 (a and b)). Optical microstructure taken from the edge showing different layers of paint (Fig. 14 (c and d)).

**Figure 14:** Optical microstructures of the base of the antenna: (a) low and (b) high magnifications; optical microstructure taken from the edge showing different layers of paint: (c) low and (d) high magnifications.

The optical microstructures taken from the edges show the paint layer at the edges (Fig. 14 (c and d)). The paint is shown by double arrows in Fig. 14 (c and d). The high magnification image (Fig. 14d) exhibits that the paint consists of three layers. These layers are marked as 1, 2 and 3 (Fig. 14d). The thicknesses of layers 1, 2 and 3 are ~ 25, 50 and 90  $\mu\text{m}$ , respectively. The microstructures and paint shown in Fig. 14 have been investigated in detail by EPMA. The EPMA elemental line scans of the paint (shown in Fig. 14) are exhibited in Fig. 17. As mentioned above, paint consists of three layers (Figs. 14 and 17). The first and third layers display the presence of Ti and C while second layer shows the Si, Cr and C elements (Fig. 17b). The small amount of oxygen is also present in all the three layers.

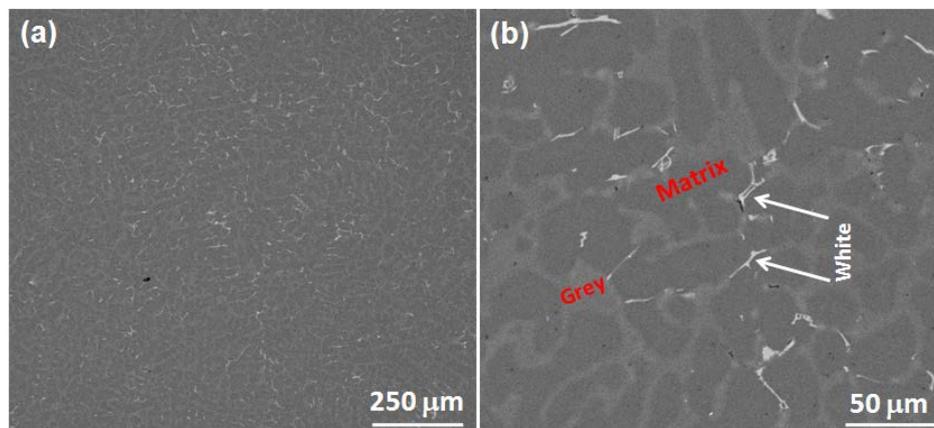
The BSE SEM (Back Scattered Electron (BSE) mode in Scanning Electron Microscopy (SEM)) microstructures taken from the cross section of base of the antenna are shown in Fig. 15. The microstructures exhibit the presence of three phases (matrix, grey and white as marked in Fig. 15b). The EPMA X-ray elemental mapping has been carried out on these phases and results are shown in Fig. 16. The distribution of Al is displayed in Fig. 16b. The elemental mappings of Ti, Fe, Mg and Si are exhibited in Fig. 16 (c-f). It is clear from the Fig. 16 that these microstructures consist of three phases. These are Al-rich matrix along with Si-rich (grey) and Mg-Si-Fe rich (white) precipitates.

**Figure 15:** The BSE SEM microstructures of cross section of the base of the antenna: (a) low and (b) high magnifications.

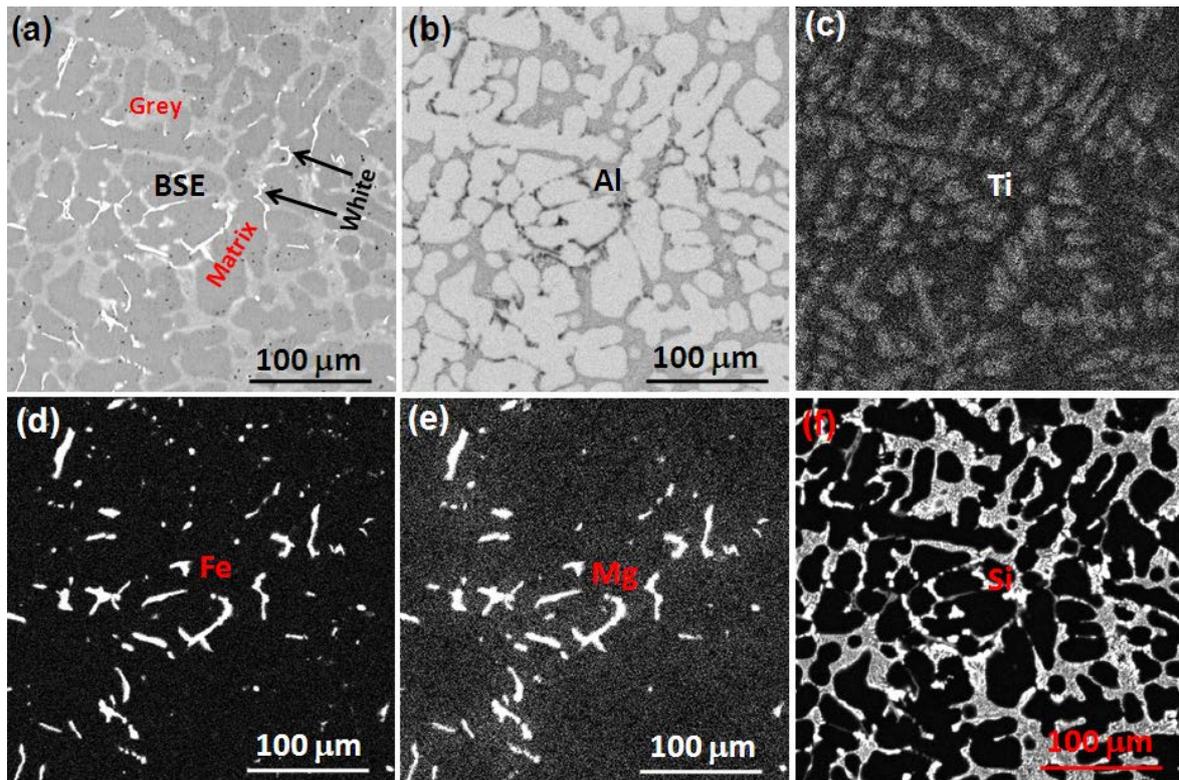
**Figure 16:** EPMA X-ray elemental mappings of cross section of base of the antenna: (a) BSE image (b) Al, (c) Ti, (d) Fe, (e) Mg and (f) Si distributions in corresponding BSE image.

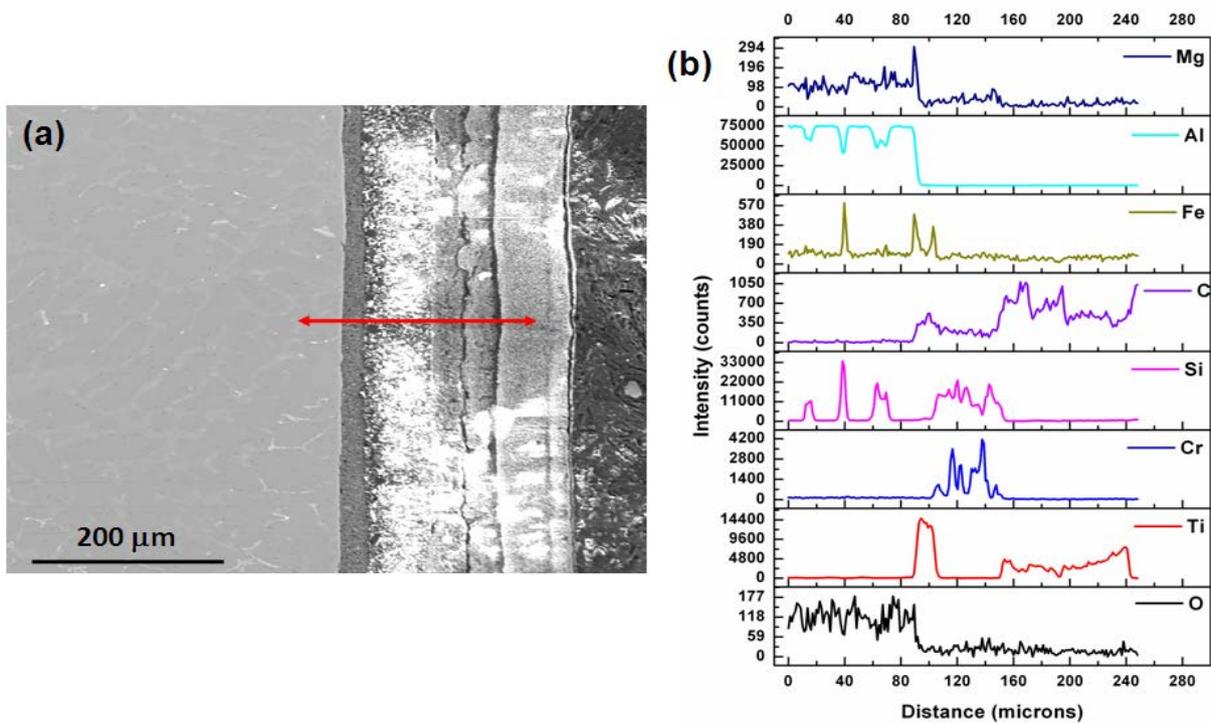
**Figure 17:** (a) BSE EPMA image taken from the edge consisting of three layers of paint. The region of line scan on paint is shown by double arrow (in red colour) and (b) EPMA elemental line scans taken from the double arrow shown in red colour in Fig. 17a.
