Failure Analysis of Diode Components of Electronic Relay Packages Via Thorough Microstructural Characterization

Mrityunjoy Hazra and Satyapal Singh

ABSTRACT

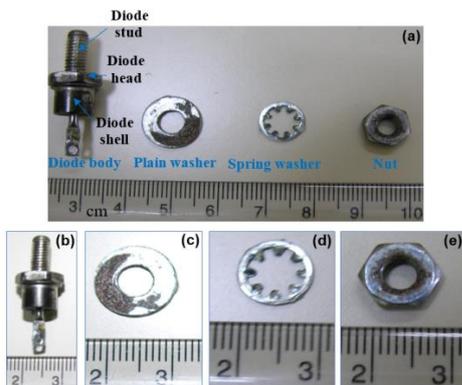
Photographs of all the as-received components are shown in Figure 3 and Figure 4 for set 1 and set 2 parts respectively. The observations are as tabulated below in Table 1. It is to be noted that the spring washer among all the components of set 1 seems to have experienced least corrosion damage, while plain washer of set 2 assembly did not reveal any sign of corrosion. The appearance of cross-sectional samples after mounting in bakelite hot mount for detailed metallographic study is as shown in Figure 5. It is to be noted that the stud part for diode body of set 2 assembly is tapered unlike that for set 1.

Figure 3: (a) Photographs of diode body, plain washer, spring washer and nut for set 1 diode assembly in the as-received condition showing corrosion with varying severity, (b-e) magnified views of the components.

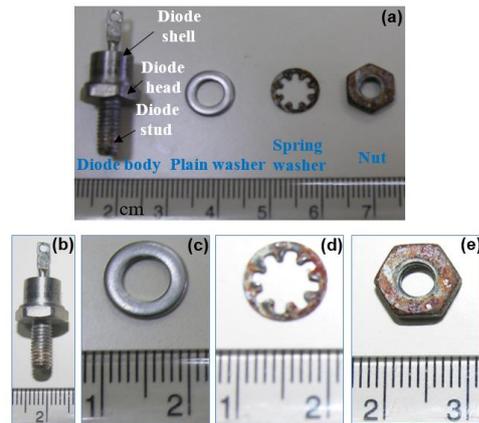
Figure 4: (a) Photographs of diode body, plain washer, spring washer and nut for set 2 diode assembly in the as-received condition showing corrosion with varying severity, (b-e) magnified views of the components.

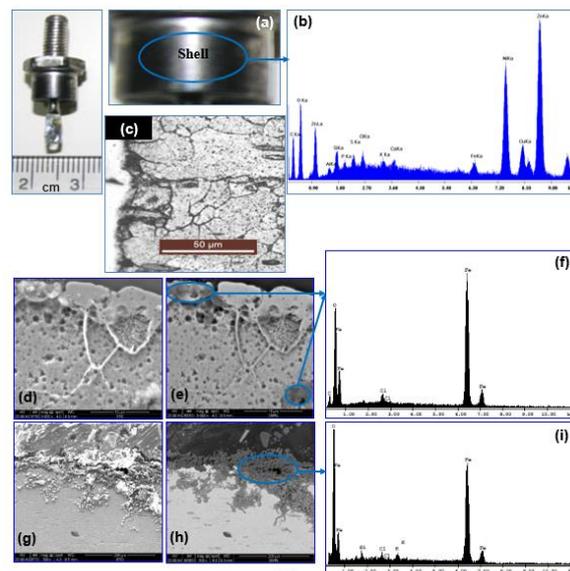
The corroded debris on the shell surface was analysed by EDS in as-received condition (Figure 6). Magnified views of the shell cross-section near the coated region are displayed in Figure 6d,e. Those analyses reveal the presence of corrosion debris on both the coating and in the interior, containing largely Fe, O and small amount of Cl, as is confirmed by the EDS analysis of Figure 6f. One more instance of observed corrosion debris is as shown in Figure 6g,h, where there is an apparent absence of the coating. Corrosion product on that place contains majorly Fe and O, along with small amounts of Cl, K and Si, as is shown in Figure 6i. Not only that, it is also noteworthy that corrosion has occurred quite significantly along the MnS stringer-matrix interface and on the stringer itself, resulting in the eating away of the shell material, as has been shown in Figure 7a-c. Many a times, the corrosion paths (cracks) followed by those stringers and stringer-matrix interfaces are matching with the ferrite grain boundaries.

Figure 6: (a) Magnified photograph of the diode shell of Figure 3a,b in the as-received condition showing the corrosion, (b) EDS results of the corrosion debris sitting on the shell, (c) optical micrograph of the corroded shell, (d,e) corrosion along the coating and deep inside the structure, (f) EDS analysis for the corrosion product shown in Figs. (d,e), (g,h) severe corrosion of the shell material along an edge in absence of coating, (i) EDS analysis for the corrosion product shown in Figs. (g,h).

Inference: The diode shell has experienced severe corrosion with the as-received corrosion debris revealing the presence of Zn, Ca, K, Fe and O beside the coating material (Ni and P). Presence of Zn indicates its transfer through corrosion product of other Zn-plated components in the assembly, while Ca and K indicate the service environmental effect. However, presence of Fe and O, at the same time, indicates slight rusting of the component. The cross-sectional micrographs along with the EDS results clearly points out the localized perforated/corroded and/or eroded EN

coating and subsequent rusting within the coating as well as shell body [7,8]. The rust has been observed upto 25 μm depth from the coated surface. Additionally, one should note that coating perforation may have been also there as a result of improper plating process, as has been noticed in the high magnification SEM images, thus aggravating the severity of corrosion on the shell. MnS stringer-induced interfacial corrosion has also been observed here, likely due to the availability of the sufficient oxygen and presence of severe stress concentration along the interface. Both plain washer and nut have been found to be rusted, as evidenced by the presence of Fe and O in the corrosion product. Nonferrous metals such as zinc, nickel, aluminium, and magnesium do not contain iron and will not 'red rust'. Red rust only becomes visible after the sacrificial metal has been depleted. Therefore, the locations with the red appearance for the components plain washer and nut had definitely lost the sacrificial action of the coating because of its depletion and got exposed to the corrosive environment, resulting in rusting. Spring washer has not shown any visual evidence for corrosion and looked quite shiny. However, it is noteworthy that Zn-O rich phase (usually coming as a result of Zn-plating) with trace amount of Fe, as obtained during the cross-sectional microstructural examination indicates the inception of corrosion process at some localized areas.

3. The electroless nickel coating applied on the diode body should be at least 25 μm thick and with almost nil porosity level, which would like to improve the general as well as galvanic corrosion resistance of the underlying material [10].

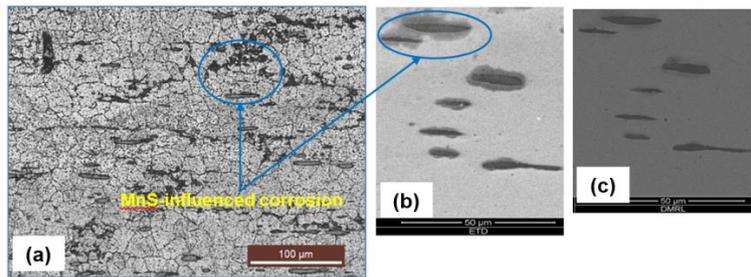
Figure 7: (a,b,c) Optical, SEM SE and SEM BSE micrographs respectively showing MnS stringer influenced corrosion along the stringer-matrix interface.

2. Steel of the diode shell should be manufactured and processed in such a way so that an optimum shape (aspect ratio) of the MnS stringers is achieved for obtaining a balance between sufficient machinability and lower (matrix-stringers) interfacial stress (and thus lower corrosion).

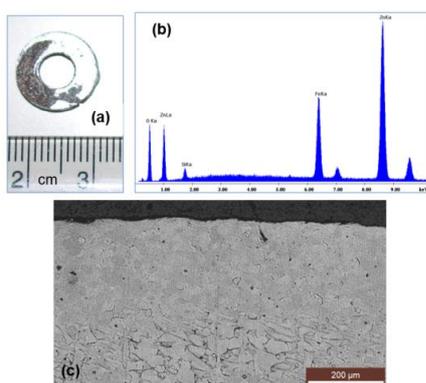
The EDS analysis on the corrosion products of the as-received part is as shown in Figure 8b. It reveals the presence of Zn, Fe, O and Si. The unetched as well as etched cross-sectional microstructure did not reveal the presence of any corrosion product. Figure 8c shows one etched photograph along an edge, in which no penetration of corrosion product into the structure was observed. It is also to be noted that the corrosion mechanism seems to be of uniform type and no pitting mechanism is present in this case.

Figure 8: (a) As-received photograph of the plain washer of Figure 3a,c showing the corrosion, (b) EDS analysis result for the corrosion debris sitting on the surface, (c) etched optical micrograph along an edge in the cross-sectional view of the severely corroded region showing uniform corrosion and no penetration of the corrosion product deep into the structure.

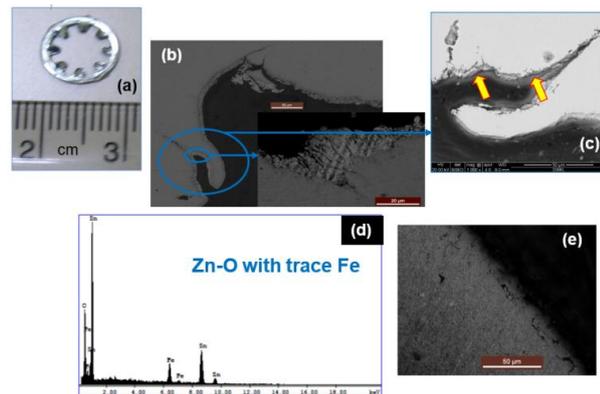
This part does not seem to have experienced any corrosion, as is quite clear from the visual appearance. Figure 9b is a cross-sectional optical micrograph of the part. Figure 9c is an SEM image. It is to be noted that there is a layer having different contrast to that of base material with average thickness of 5 μm . At locations, the layer thickness has been found to be as high as 20 μm . The EDS analysis of the region reveals the presence of Zn, Fe and O, as shown in Figure 9d. It was also observed to possess pitted surface, as is shown in Figure 9e.

Figure 9: (a) As-received photograph of the spring washer of Figure 3a,d showing the corrosion, (b,c) respective optical and SEM BSE image showing corrosion products along an edge in the cross-sectional view, (d) EDS analysis result for the corrosion product shown in Figure 9c, (e) etched optical micrograph along an edge showing severe pitting.

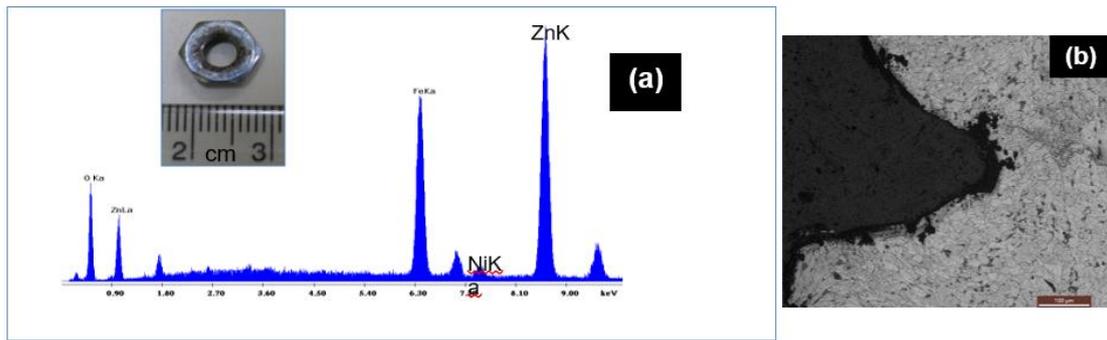
The corrosion product of the as-received part is as shown in the EDS result of Figure 10a. It reveals the presence of Zn, Fe, O and Ni. The etched cross-sectional microstructure at some of the corroded regions reveals the presence of pitting, as is shown in Figure 10b.

Figure 10: (a) EDS analysis result for the corrosion product sitting on the surface of nut (inset: as-received photograph showing the corrosion of nut) (b) etched optical micrograph along the threaded region showing moderate degree of pitting.

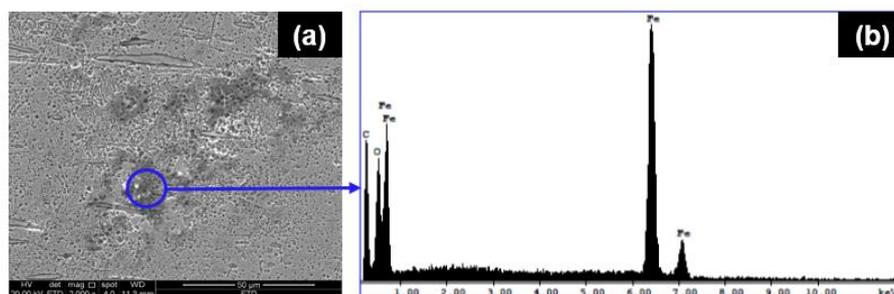
There was no corrosion debris sitting on the as-received diode body, as observed during visual inspection. However, corrosion product containing Fe and O has been detected, up to a depth of 100 μm below the EN coating, while examining the cross-sectional sample. This has been shown in Figure 15a and corresponding EDS analysis is given in Figure 15b.

Figure 15: (a) Optical micrograph of the corroded shell showing corrosion deep inside the structure, (b) EDS analysis for the corrosion product shown in Figure 15a.

Inference: The diode shell has experienced inception of corrosion internally presumably due to the presence of perforation in the EN coating and/or local corrosion on coating and subsequently that of the shell material [7, 8]. Another factor of great concern may be that the diode body was moderately corroded prior to the EN plating. MnS stringer-induced interfacial corrosion has also been observed here, likely due to the availability of the sufficient oxygen and presence of severe stress concentration along the interface. Spring washer has shown rusting - both in uniform and pit form. On the other hand, plain washer did not show any trace of corrosion due to the superior corrosion resistance of passivated/pre-oxidized AISI 316 type of stainless steel to that of Zn-coated low carbon steel. Nut has been found to be affected by corrosion deep into the structure and that manifested as reddish rusts on the surface.

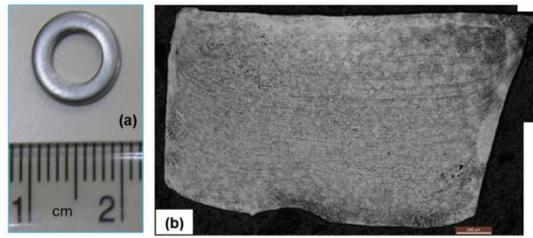
There was no corrosion product observed on the surface of the as-received part, as is presented in Figures 4a,c and 16a. Figure 16b shows etched whole cross-sectional micrograph so as to look into and present the corrosion features of this part, if any. However, no signature of corrosion could be traced out, as is clearly seen in the micrograph.

Figure 16: (a) As-received photograph of the plain washer of Figure 4a,c showing no sign of corrosion, (b) optical micrograph of the whole cross-section with no trace of corrosion, etchant: aqua-regia.

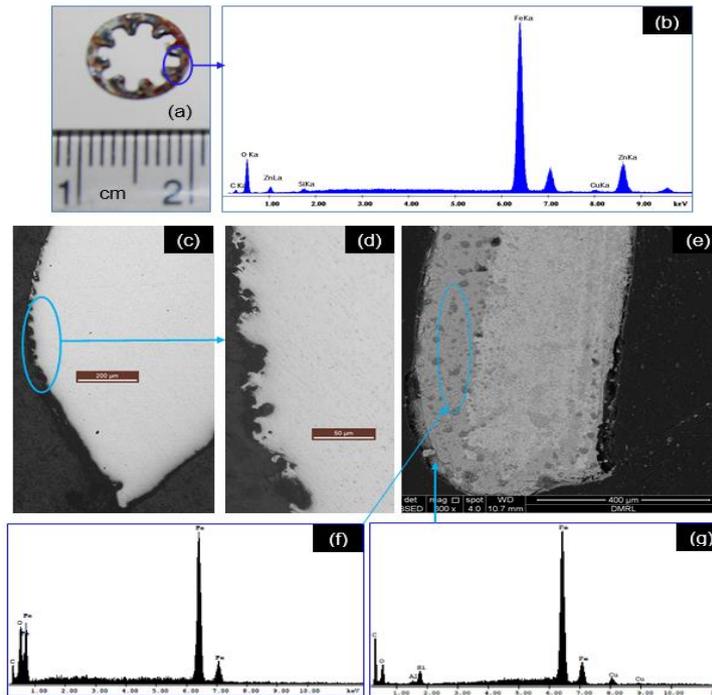
This part had experienced severe corrosion, as is quite clear from the reddish surface appearance observed during visual inspection (Figure 4a,d and Figure 17a). That reddish deposit has been analysed in as-received condition and found to contain product rich in Fe and O, as is shown in Figure 17b. Figure 17c,d are the cross-sectional micrographs in unetched condition, revealing severe pitting of the part. Figure 17e is an optical micrograph in etched condition, showing etched layers along the edge with different contrasts to that of interior. In this image, both uniform attack (of $\approx 100 \mu\text{m}$ depth) and pitting attack have been shown and the corrosion product has been found to be rich in Fe and O for both the form, as is shown by the EDS results in Figure 17f,g.

Figure 17: (a) As-received photograph of the spring washer of Figure 4a,d showing severe corrosion, (b) EDS analysis result for the corrosion debris on the as-received washer, (c,d) unetched optical micrographs along an edge showing severe pitting, (e) etched optical micrograph showing uniform as well as pitting corrosion, (f,g) EDS analysis results for the corrosion products shown in Figure 17e.

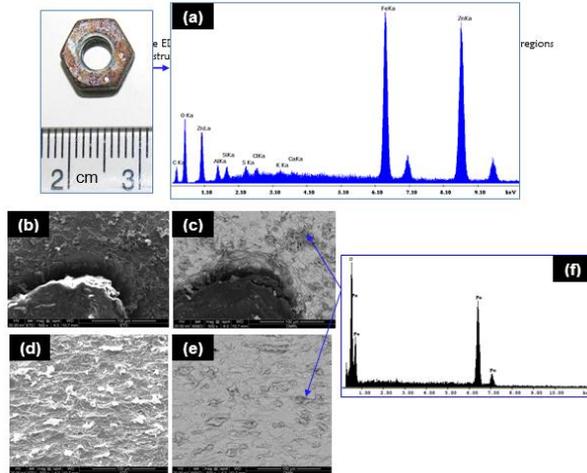
The corrosion product of the as-received part is as shown in the EDS result of Figure 18a along with the as-received photograph. Severe corrosion has been evidenced by the reddish surface appearance as well as the EDS results containing Fe, Zn, O, K, Ca, S, Si and Al. The etched SEM micrographs along the thread are shown in Figure 18(b,c) and (d,e) in both SE and BSE modes. The imaging at different locations of the nut sample as well as the EDS analysis confirms the presence of Fe-O rich phases at both the threaded regions and deep inside the structure, as has been typified here.

Figure 18: (a) EDS analysis result for the corrosion debris on the as-received nut, (b,c) scanning electron micrographs along the threaded region under respective SE and BSE modes showing presence of corrosion products, (d,e) scanning electron micrographs away from the threaded region and deep into the structure under respective SE and BSE modes showing presence of corrosion products, (f) EDS analysis results for the corrosion products.

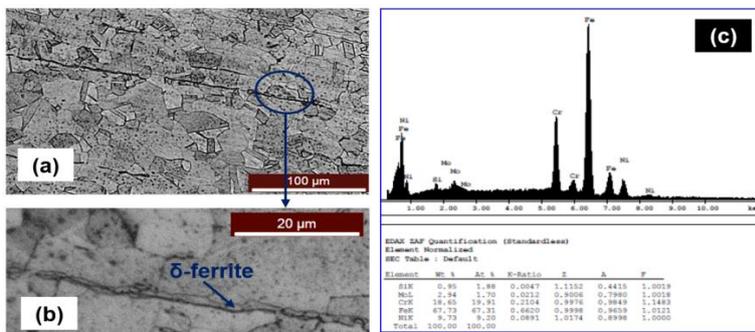
Figure 20: (a) Cross-sectional etched optical micrograph of the plain washer, etchant: aqua-regia, (b) magnified view of the encircled region showing chain like δ -ferrite, (c) EDS analysis of the base material for plain washer.

9. For set 2 assembly, stainless steel plain washer should not contain excess Cr (≈ 20 wt.% in this case) than is required ($12 \leq Cr \leq 18$, in wt.%, as in AISI 316) for reasonable corrosion resistance. This is to avoid brittle δ -ferrite phase formation, which may also affect the corrosion resistance of austenitic matrix by sucking more and more Cr into it. Schaffler diagram should be consulted for desired compositional balance in this regard [13]. Also, solutionizing temperature should be maintained within 1050-1100°C and soaking time should be reasonably low to avoid that phase.
