Failure Analysis of Diode Components of Electronic Relay Packages Via Thorough Microstructural Characterization

Mrityunjoy Hazra and Satyapal Singh

ABSTRACT

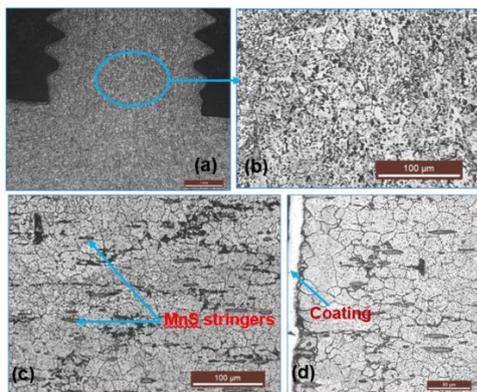
Figure 11: (a) Cross-sectional optical micrograph of the diode stud portion in etched condition, etchant: acidified potassium dichromate, (b) magnified view of the encircled region in Figure 11, (c) diode shell microstructure in etched condition showing MnS stringers, etchant: 2% nital, (d) etched shell microstructure in higher magnification showing whitish coating.

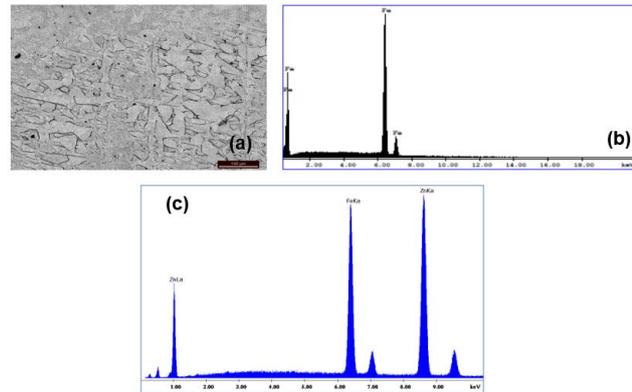
Figure 12: (a) Cross-sectional etched optical micrograph of the plain washer, etchant: 2% nital, (b) EDS analysis of the base material for plain washer, (c) EDS analysis of the coating for plain washer.

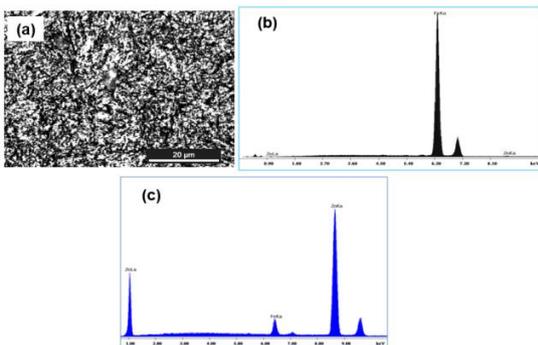
Figure 13: (a) Cross-sectional etched optical micrograph of the spring washer, etchant: 5% nital, (b) EDS analysis of the base material for spring washer, (c) EDS analysis of the coating for spring washer.

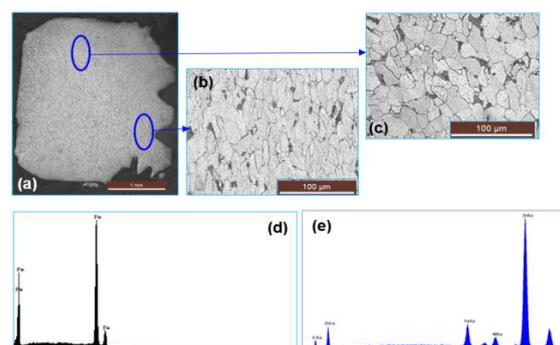
Figure 14: (a-c) Cross-sectional etched optical micrographs of the nut, etchant: 2% nital, (b) EDS analysis of the base material for nut, (c) EDS analysis of the coating for nut.

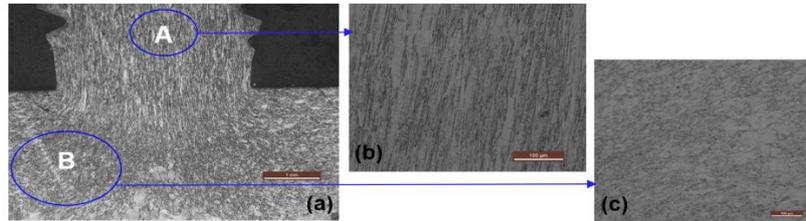
Figure 19: (a) Cross-sectional optical micrograph of the diode stud portion in etched condition, etchant: acidified potassium dichromate, (b) magnified view of the encircled regions in Figure 19a.

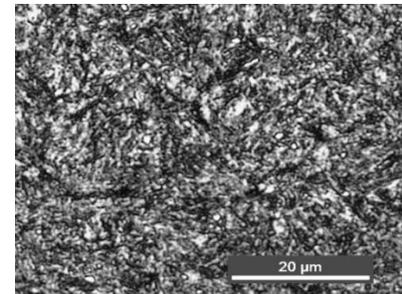
Figure 21: Cross-sectional etched optical micrograph.

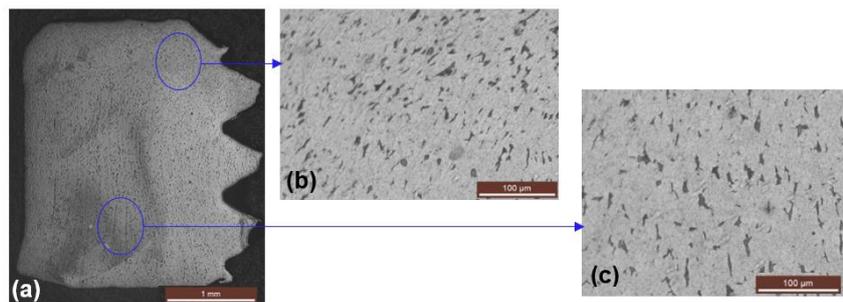
Figure 22: (a-c) Cross-sectional etched optical micrographs of the nut, etchant: 2% nital.
